# INSPECTION REPORT

766 University Ave.  
St. Paul, MN 55104

September 10, 2014

Property Address: 766 University Ave.  
St. Paul, MN 55104

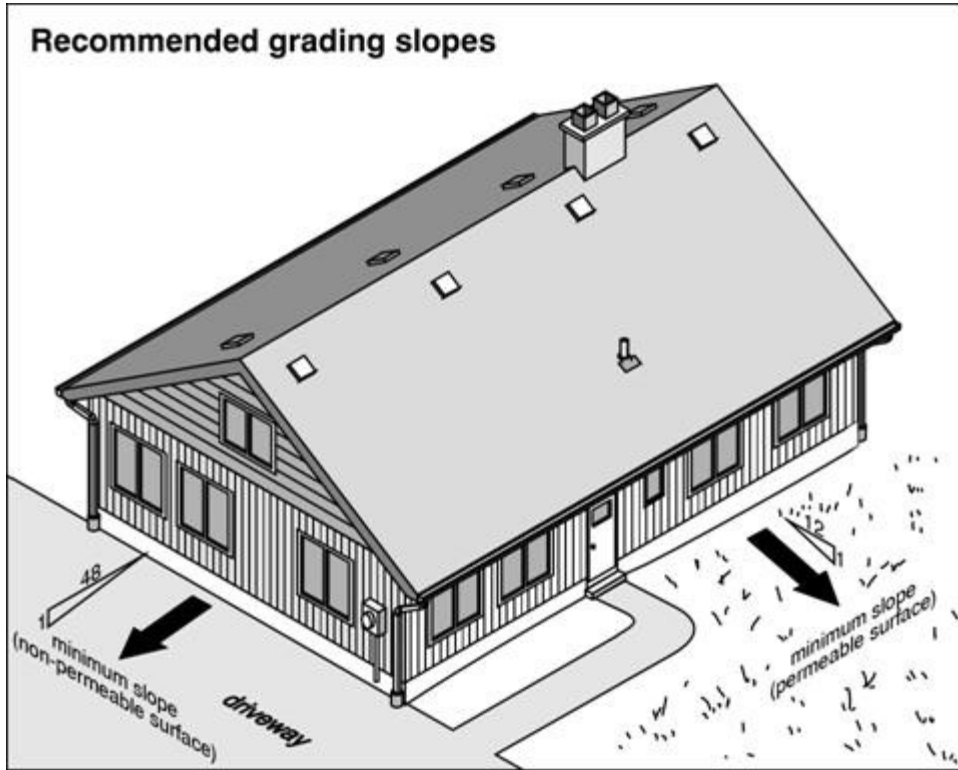
<u>F</u>	<u>C</u>	<u>D</u>	F = Functional	C = Comment	D = Defect
Grading & drainage:						
front	<input type="checkbox"/>	<input checked="" type="checkbox"/>	<input type="checkbox"/>	flat grading and/or low areas near the foundation --	grading/drainage improvements recommended -- see Yard Notes	below and illustration(s) on the next page
right side	<input type="checkbox"/>	<input checked="" type="checkbox"/>	<input type="checkbox"/>	flat grading and/or low areas near the foundation --	grading/drainage improvements recommended -- see Yard Notes	below and illustration(s) on the next page
rear	<input type="checkbox"/>	<input checked="" type="checkbox"/>	<input type="checkbox"/>	flat grading and/or low areas near the foundation --	grading/drainage improvements recommended -- see Yard Notes	below and illustration(s) on the next page
left side	<input type="checkbox"/>	<input checked="" type="checkbox"/>	<input type="checkbox"/>	flat grading and/or low areas near the foundation --	grading/drainage improvements recommended -- see Yard Notes	below and illustration(s) on the next page

**Yard Notes:** Earth grade should slope away from the foundation of the house at a rate of 1" per foot for the first 8 feet. The lot should then allow for drainage off the site to the street or other designated drainage area. Hard surfaces such as driveways, patios, sidewalks, steps and decks should also slope slightly away from house foundation (1/8" to 1/4" per foot). Improvements in these areas will help minimize soil/water pressure against foundation walls and the potential for seepage into basement. See illustrations on the next page.
