INSPECTION REPORT

313 Webster St.
St. Paul, MN 55102

PREPARED FOR:
Ramsey County T.F.L. / Paul Scharf

September 12, 2014

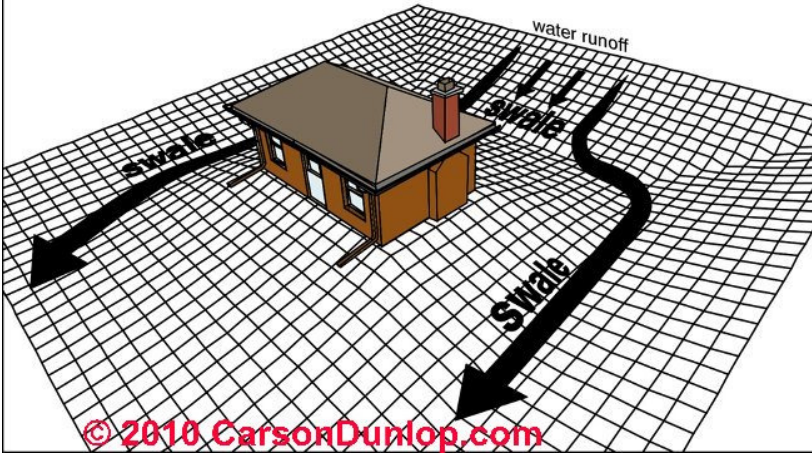
Swales

<u>F</u>	<u>C</u>	<u>D</u>	F = Functional	C = Comment	D = Defect
Grading & drainage:						
front	<input type="checkbox"/>	<input checked="" type="checkbox"/>	<input type="checkbox"/>	flat grading --	grading/drainage improvements recommended --	see Yard Notes below and illustration(s) on the next page
right side	<input type="checkbox"/>	<input checked="" type="checkbox"/>	<input type="checkbox"/>	flat grading --	grading/drainage improvements recommended --	see Yard Notes below and illustration(s) on the next page
rear	<input type="checkbox"/>	<input checked="" type="checkbox"/>	<input type="checkbox"/>	flat grading --	grading/drainage improvements recommended --	see Yard Notes below and illustration(s) on the next page
left side	<input type="checkbox"/>	<input checked="" type="checkbox"/>	<input type="checkbox"/>	low areas near the foundation --	grading/drainage improvements recommended --	see Yard Notes below and illustration(s) on the next page

when the overall lot drainage is toward the house, swales can be used to direct surface water away from the foundation

Yard Notes: Earth grade should slope away from the foundation of the house at a rate of 1" per foot for the first 8 feet. The lot should then allow for drainage off the site to the street or other designated drainage area. Hard surfaces such as driveways, patios, sidewalks, steps and decks should also slope slightly away from house foundation (1/8" to 1/4" per foot). Improvements in these areas will help minimize soil/water pressure against foundation walls and the potential for seepage into basement. See illustrations on the next page.
