INSPECTION REPORT

905 Armstrong Ave. W.
St. Paul, MN 55102

PREPARED FOR:
Ramsey County T.F.L.
Paul Scharf

September 12, 2014

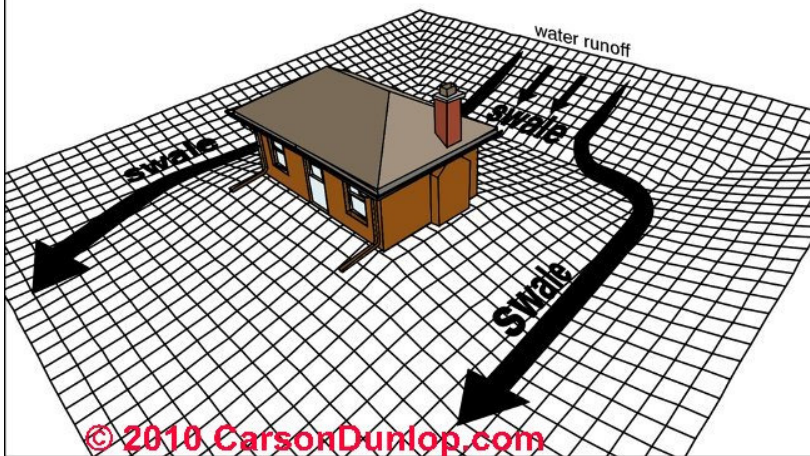
Swales

when the overall lot drainage is toward the house, swales can be used to direct surface water away from the foundation

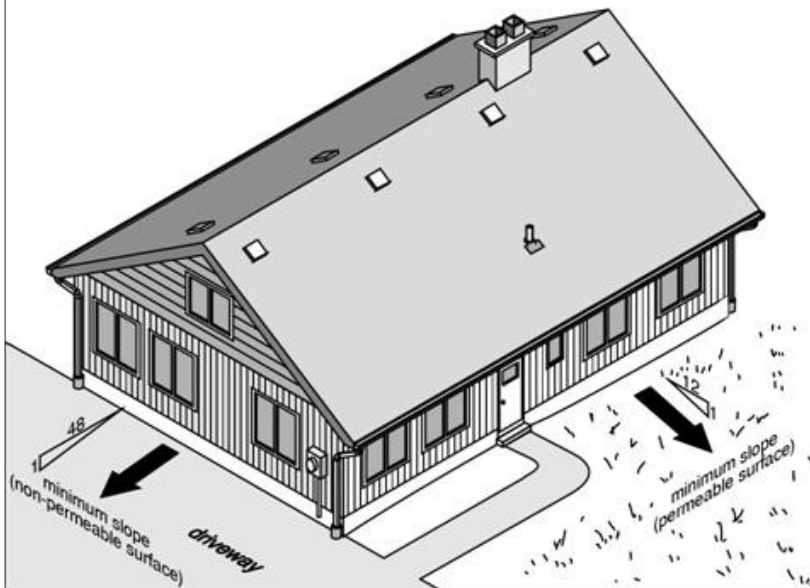
Recommended grading slopes

Yard Notes: Earth grade should slope away from the foundation of the house at a rate of 1" per foot for the first 8 feet. The lot should then allow for drainage off the site to the street or other designated drainage area. Hard surfaces such as driveways, patios, sidewalks, steps and decks should also slope slightly away from house foundation (1/8" to 1/4" per foot). Improvements in these areas will help minimize soil/water pressure against foundation walls and the potential for seepage into basement. See illustrations on the next page.
