August 14, 2013

**RE: Asbestos/Pre-Demolition Inspection Letter Report  
Vacant Duplex  
614 W. Edmund Avenue  
St. Paul, Minnesota 55103  
Bay West Job J130371**

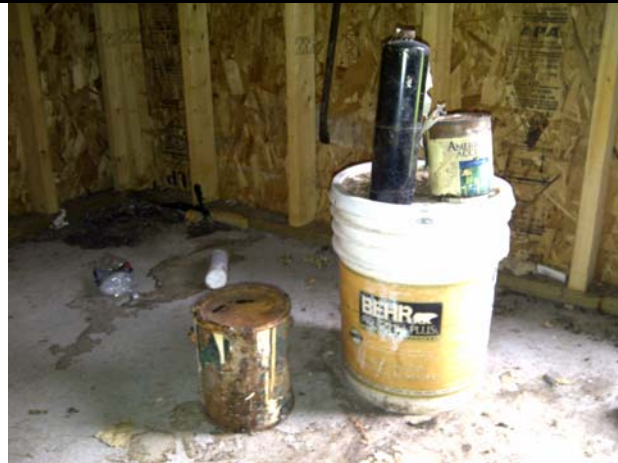
3: Household hazardous waste (HHW) located in the garage

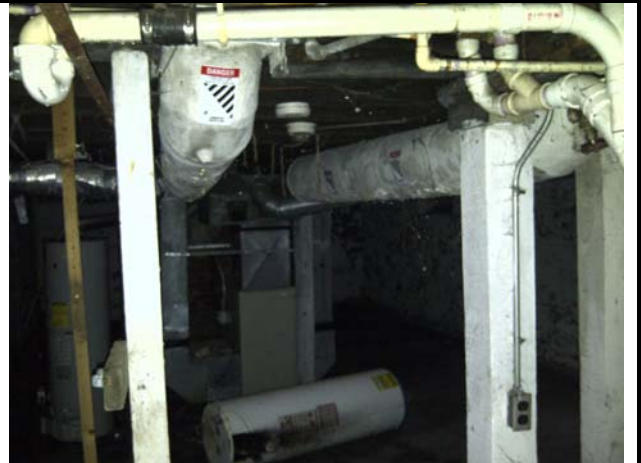
4: Assumed ACM piping in the basement.

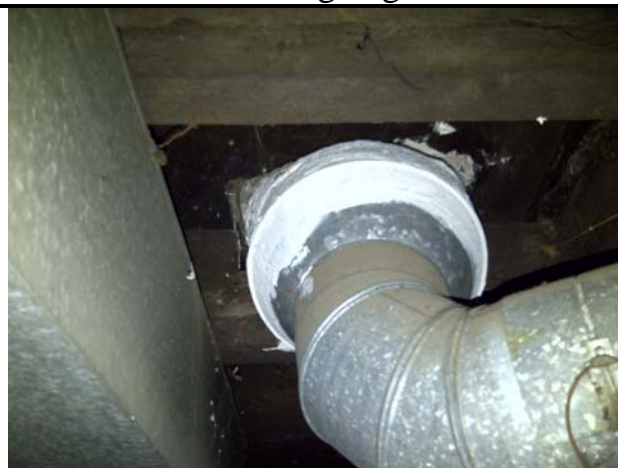
5: Assumed ACM piping in the basement.

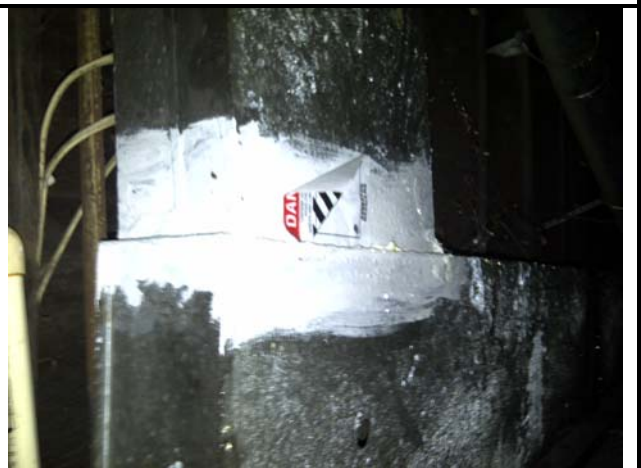
6: Assumed ACM ducting joint compound in the basement.

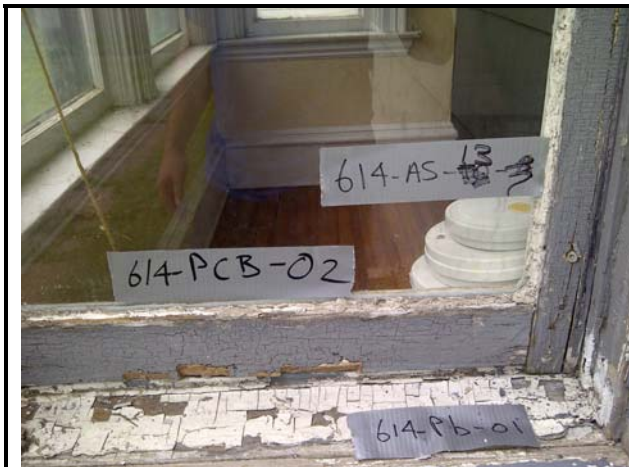
7: Sample Pb-1 – Lead 20% & Pb-2 – Lead 28%

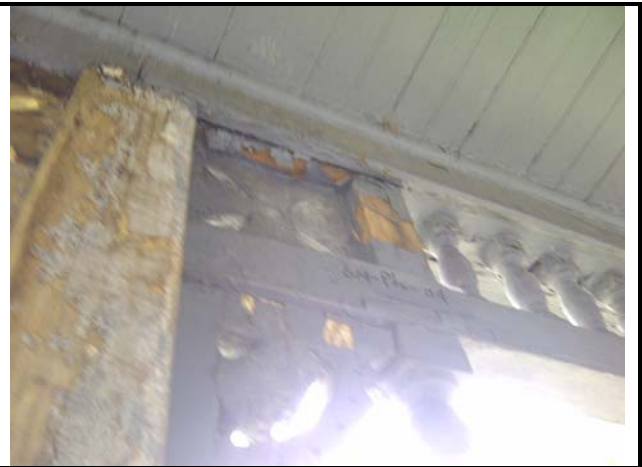
8 Sample Pb-4 – Lead 31%

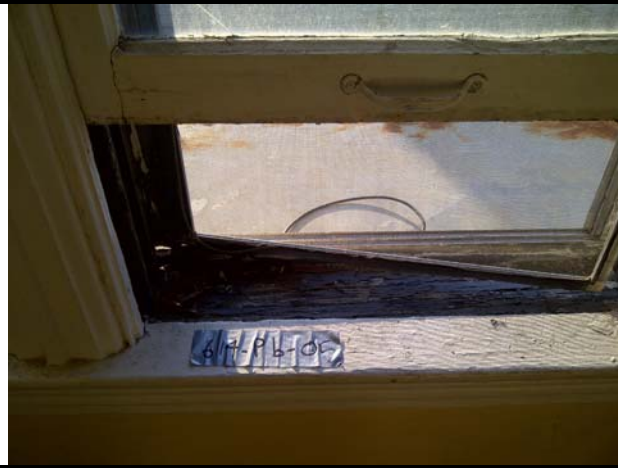
9: Sample Pb-5 – Lead 1.1%

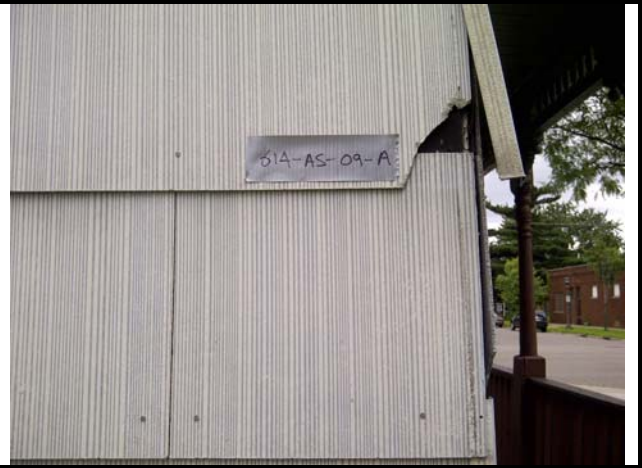
10: 614-AS-09-A – 25% Chrysotile

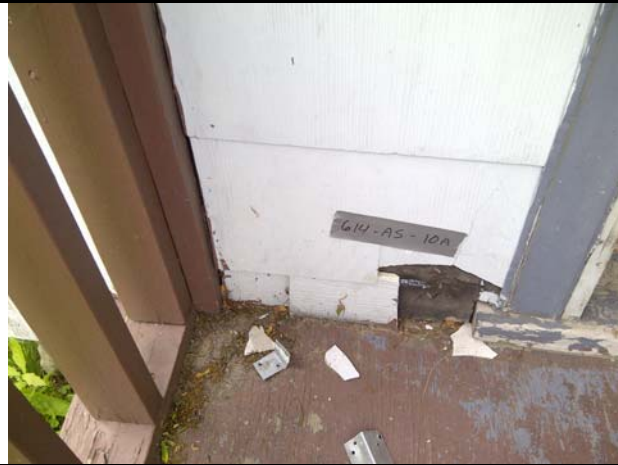
11: 614-AS-10-A – 25% Chrysotile

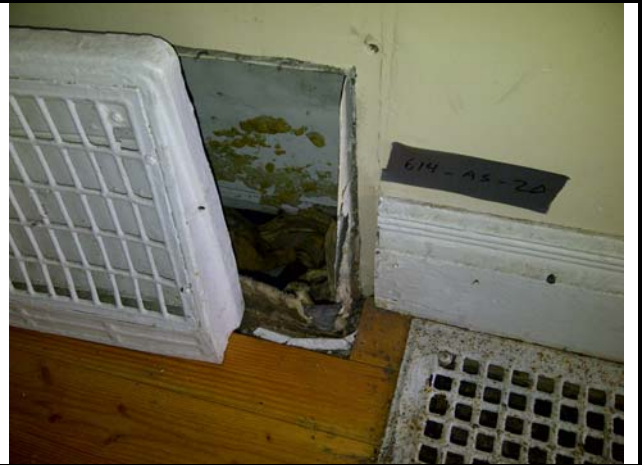
12: 614-AS-20 – 75% Chrysotile

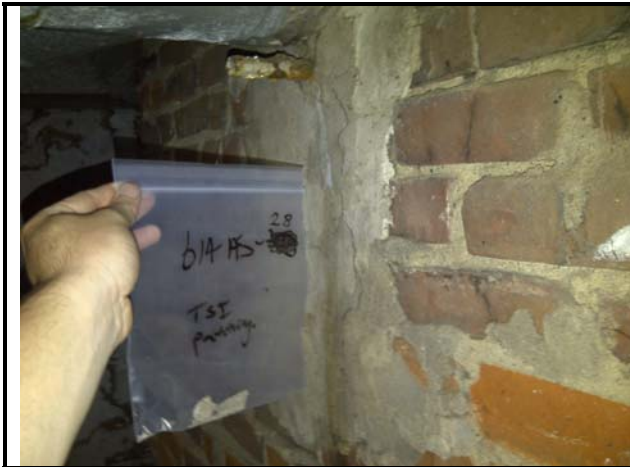
13: 614-AS-28 – 8.9% Chrysotile

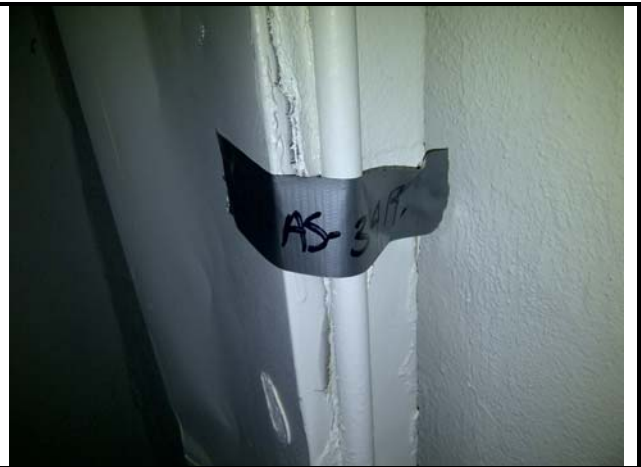
14: 614-AS-34-A – 65% Chrysotile

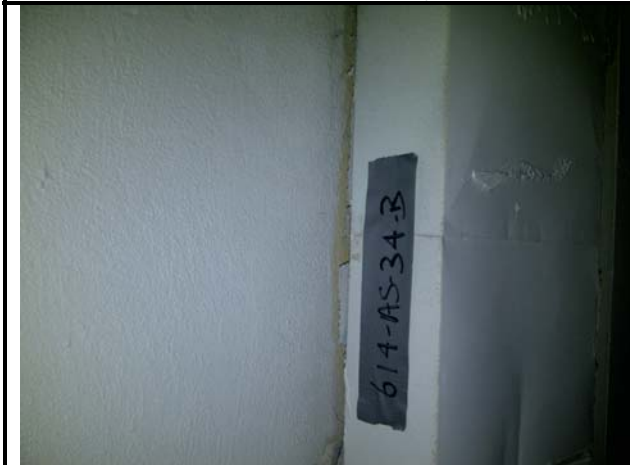
15: 614-AS-34-B – 65% Chrysotile
