Pre-Renovation Hazardous Building Materials Inspection Report

Residential Building
911 Beech Street
Saint Paul, Minnesota

Project B1602097
May 3, 2016

Re: Pre-Renovation Hazardous Building Material Inspection Report
Residential Building
911 Beech Street
Saint Paul, Minnesota

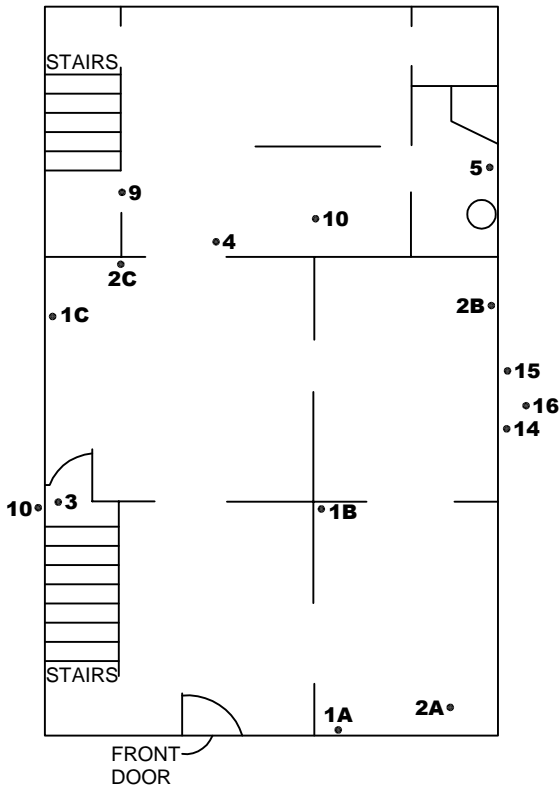
Sample Location Sketch

NOTE: SAMPLES 10,11,12, AND 13 WERE COLLECTED FROM THE BASEMENT ADJACENT TO THE CHIMNEY
SAMPLE 17 COLLECTED FROM THE ROOF OF THE MAIN STRUCTURE

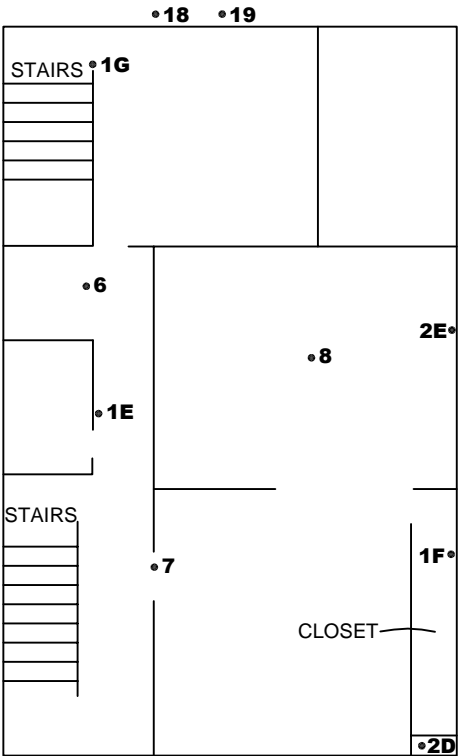
NOTE: NO SAMPLES COLLECTED FROM THE THIRD FLOOR
