Pre-Renovation Hazardous Building Materials Inspection Report

Residential Duplex Building
1022 Freemount Avenue
Saint Paul, Minnesota

Project B1602097.02
May 5, 2016

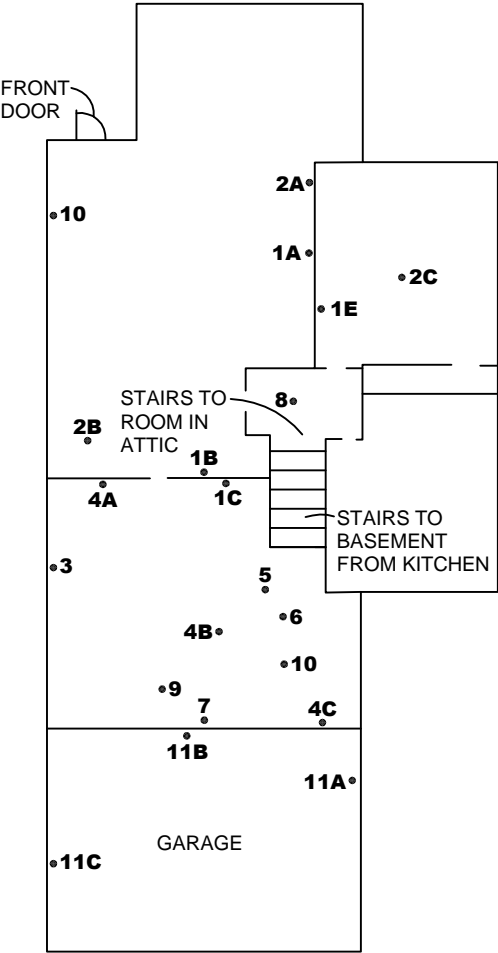
Sample Location Sketch

NOTE: SAMPLES 8 AND 9 COLLECTED IN THE BASEMENT
SAMPLES 12 THROUGH 15 COLLECTED FROM ROOF FROM 2ND LEVEL SOUTH WINDOW
