Pre-Renovation Hazardous Building Materials Inspection Report

Residential Building
957 Mendota Street
Saint Paul, Minnesota

Project B1602097.01
May 5, 2016

Braun Intertec Corporation

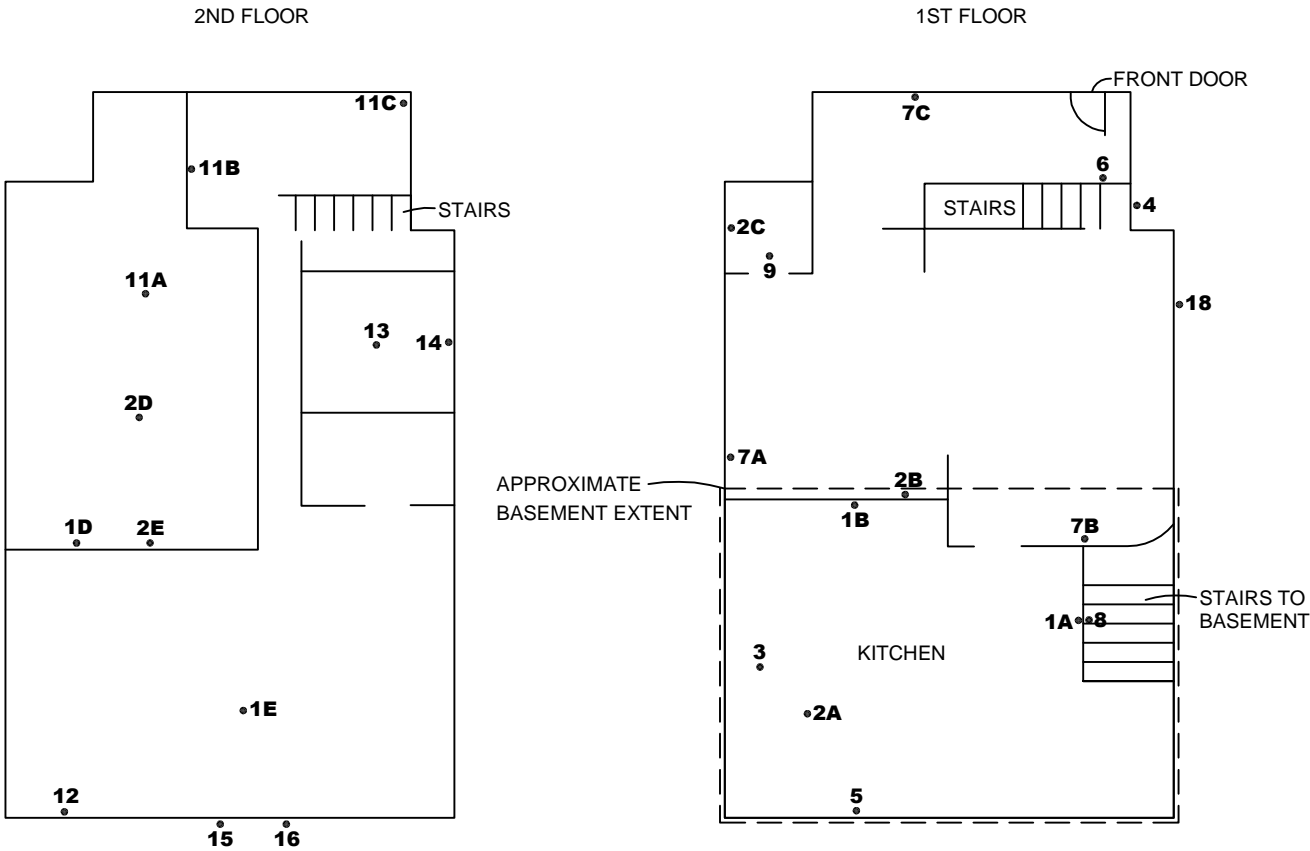
Sample Location Sketch

NOTE: DUCT TAPE NEAR CHIMNEY COLLECTED IN BASEMENT
