Pre-Renovation Hazardous Building Materials Inspection Report

Residential Building
2070 Manitou Avenue
St. Paul, Minnesota

April 9, 2018

Project B1801954

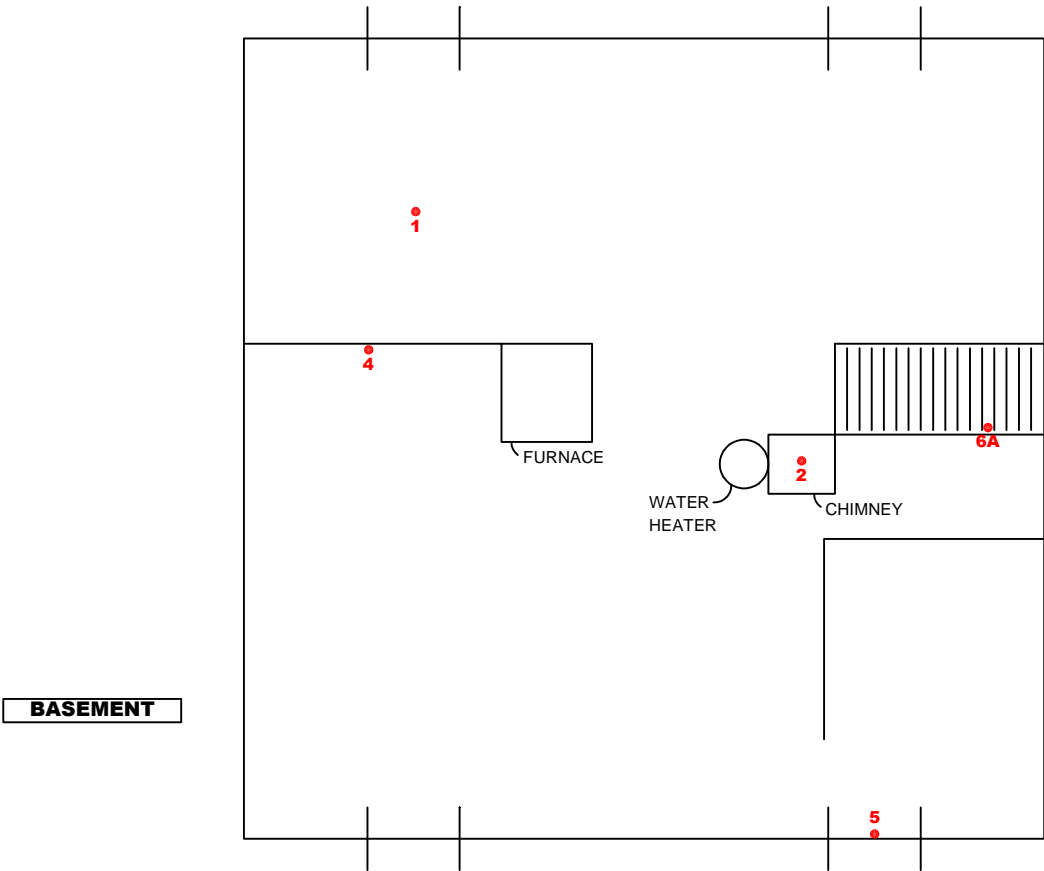
Sample Location
Sketch

● ASBESTOS SAMPLE LOCATION
