# INSPECTION REPORT

4173 Clover Ave.  
Vadnais Heights, MN 55127

PREPARED FOR:  
Ramsey County T.F.L. / Paul Scharf

April 22, 2018

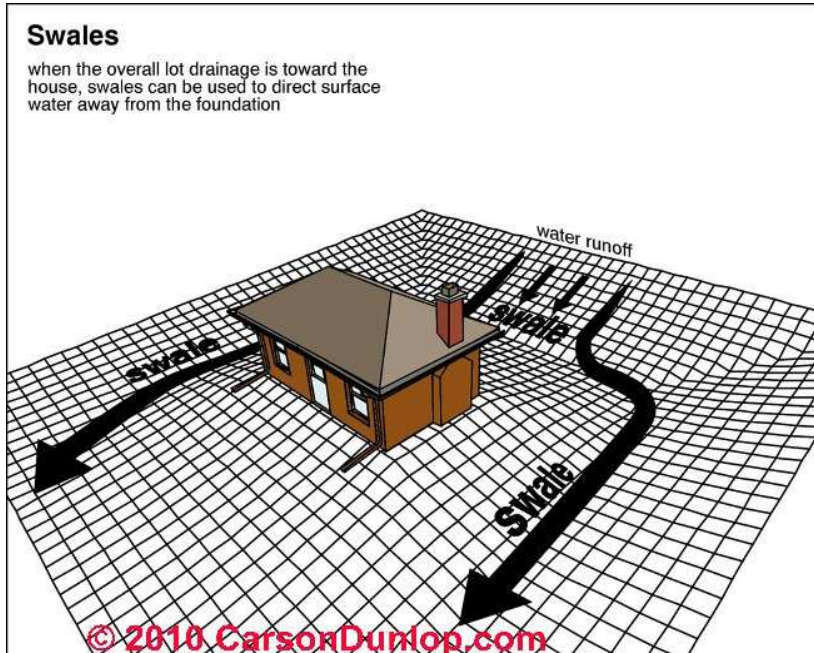
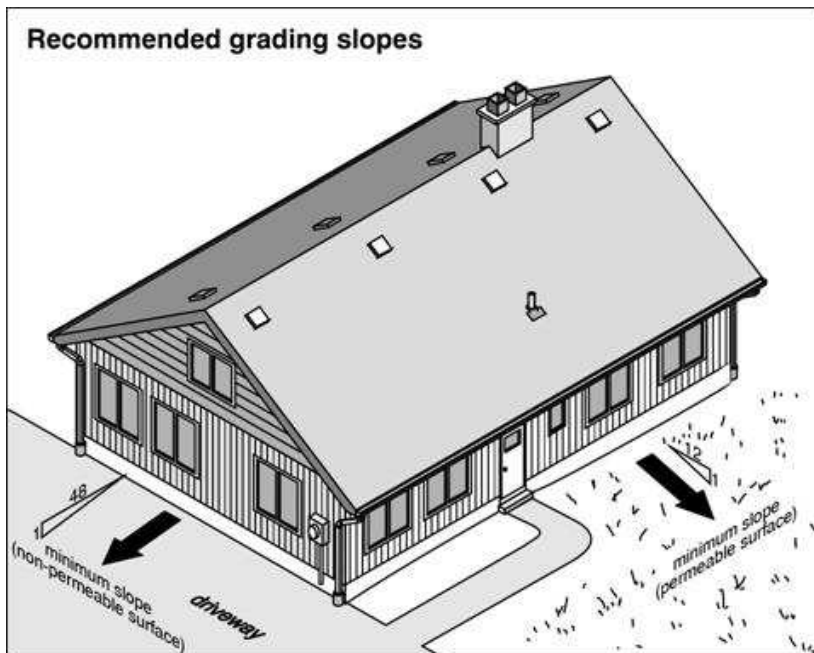
**Yard Notes:** Earth grade should slope away from the foundation of the house at a rate of 1" per foot for the first 8 feet. The lot should then allow for drainage off the site to the street or other designated drainage area. Hard surfaces such as driveways, patios, sidewalks, steps and decks should also slope slightly away from house foundation (1/8" to 1/4" per foot). Improvements in these areas will help minimize soil/water pressure against foundation walls and the potential for seepage into basement. See illustrations below.
