**RE: 1799 York Avenue, St. Paul, Minnesota  
Asbestos, Lead, and Hazardous Materials Inspection  
IEA Project #201910288**

**ASBESTOS, LEAD &  
HAZARDOUS MATERIALS INSPECTION  
PROFILE**

**Single Family Residence  
1799 York Avenue  
St. Paul, Minnesota 55119**

**IEA Project #201910288**

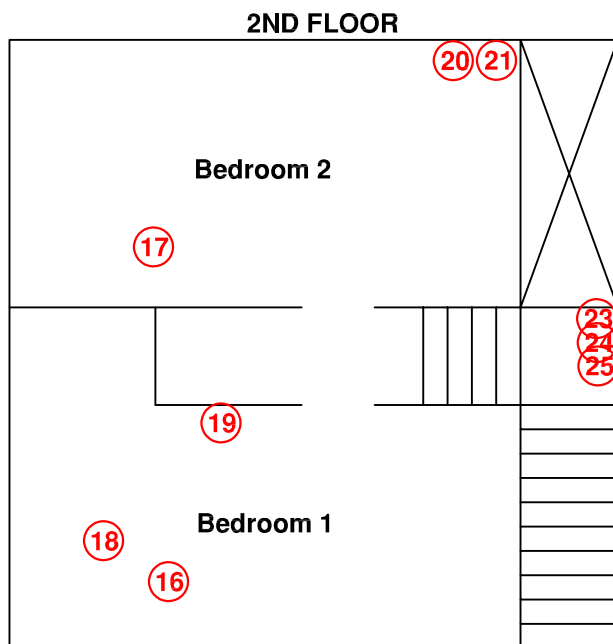
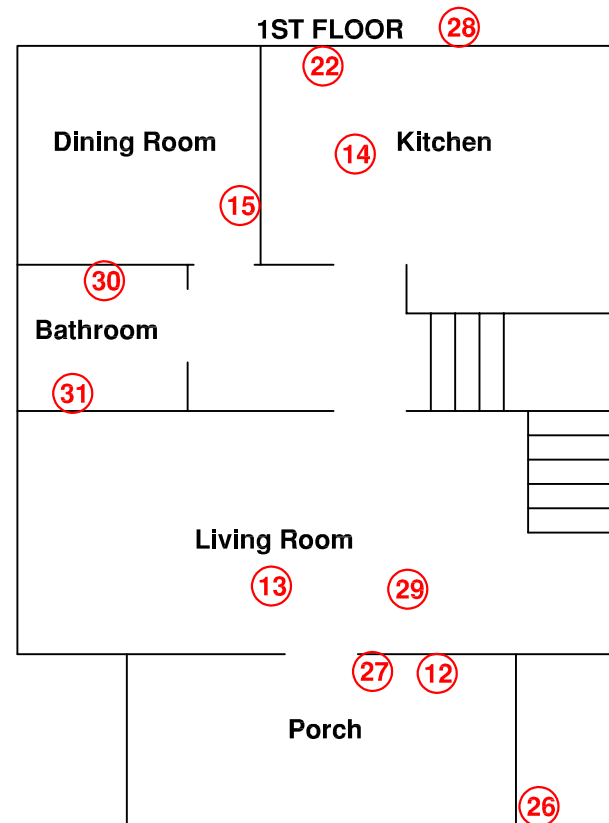
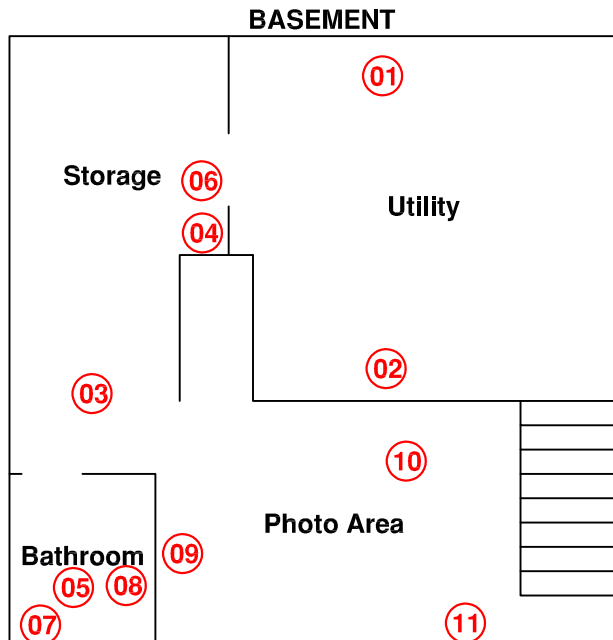
Mar. 2019 | Figure 01

1799 York Avenue, St. Paul, MN, Sample Location Map
