# **INSPECTION REPORT**

53 Maryland Ave. E. St. Paul, MN 55117

PREPARED FOR: Ramsey County T.F.L. Paul Scharf

September 14, 2014

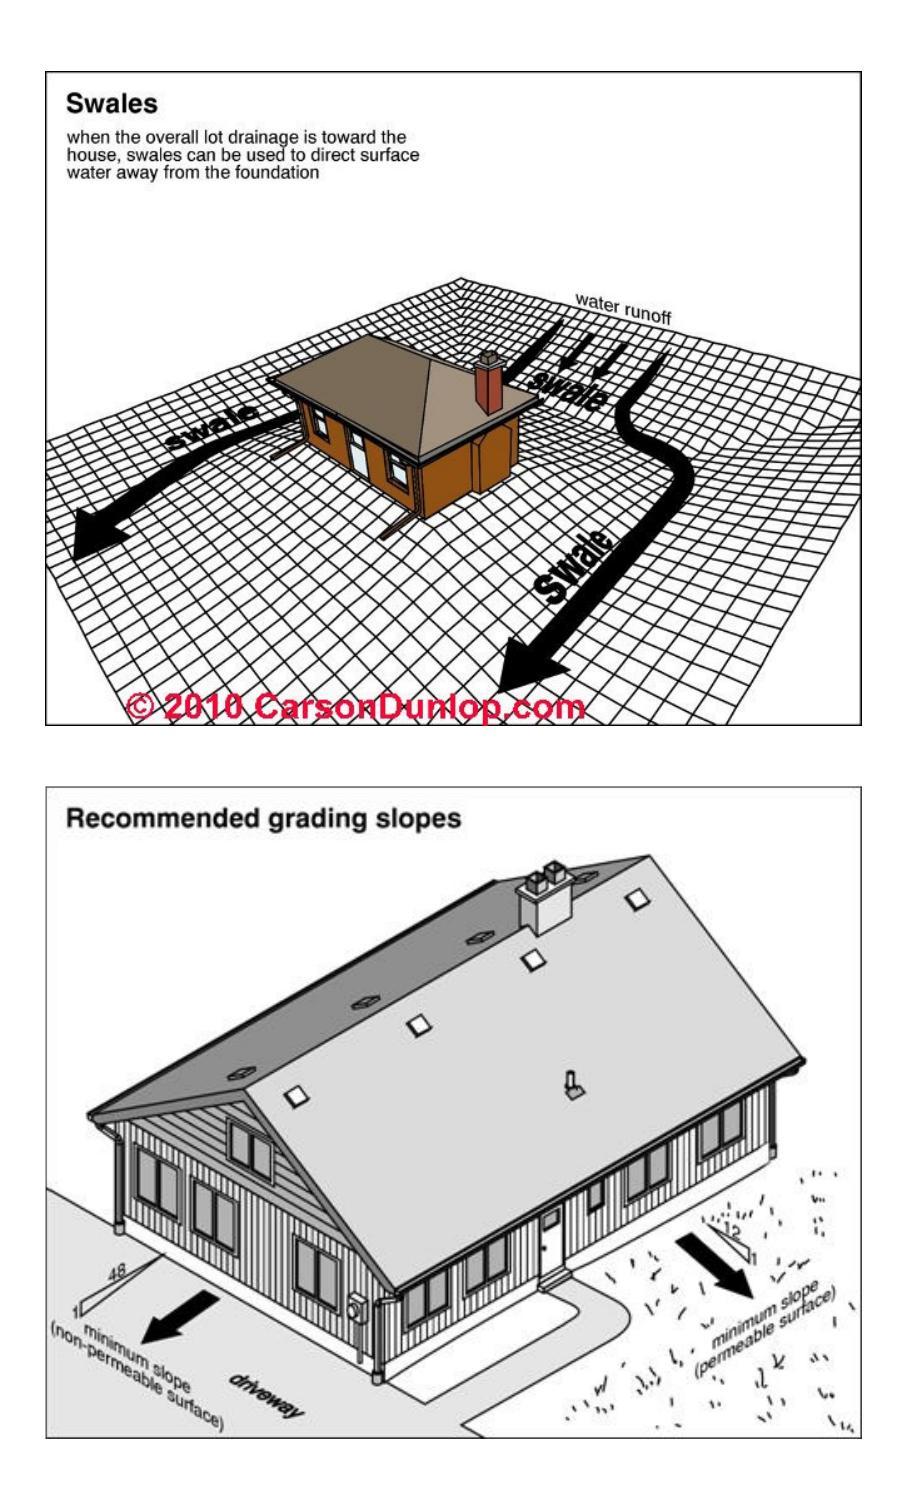
**Yard Notes:** Earth grade should slope away from the foundation of the house at a rate of 1" per foot for the first 8 feet. The lot should then allow for drainage off the site to the street or other designated drainage area. Hard surfaces such as driveways, patios, sidewalks, steps and decks should also slope slightly away from house foundation (1/8" to 1/4" per foot). Improvements in these areas will help minimize soil/water pressure against foundation walls and the potential for seepage into basement. See illustrations on the next page.
