Prairie Home Inspections

CONFIDENTIAL INSPECTION REPORT

588 Ferndale St N, Maplewood, MN 55119

4/28/2015 9:45am to 12:15pm

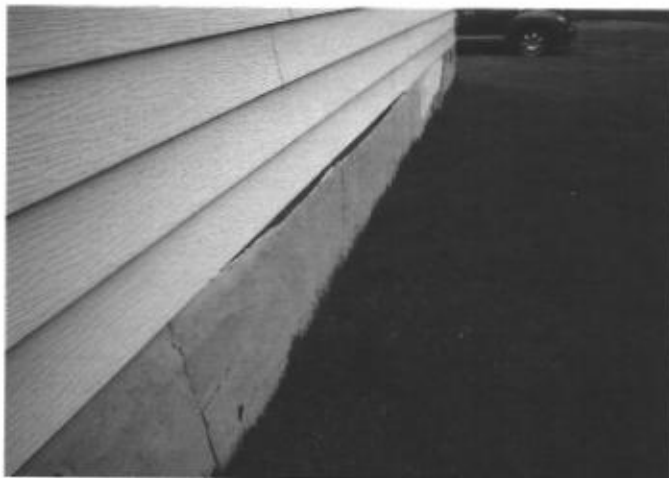
- * The below grade space is a block basement with a concrete floor.
- * There is loose insulation board on the exterior of the foundation on the West addition to the home.

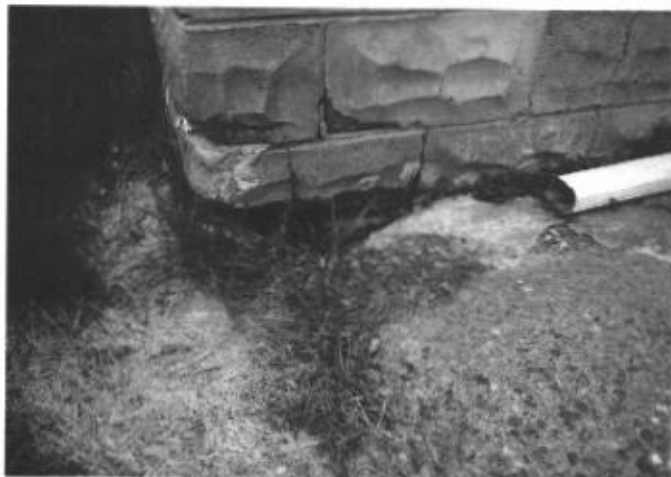
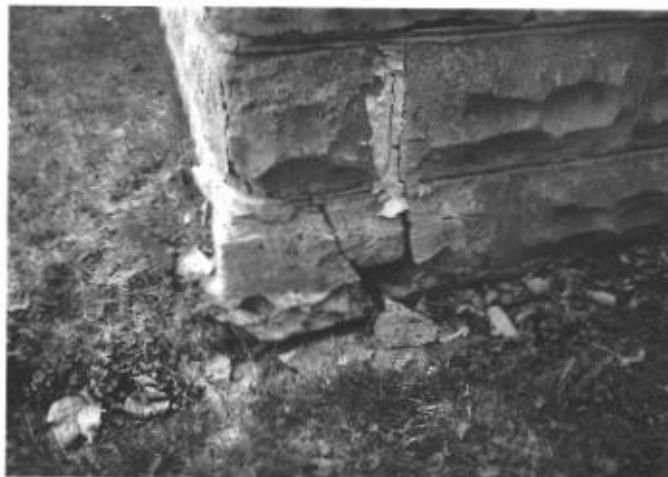
- ☐ The SE and NE corners of the foundation have damaged and deteriorated block. The foundation is weakened in these areas and is permitting moisture and possibly pests to enter. Foundation block repairs are needed.

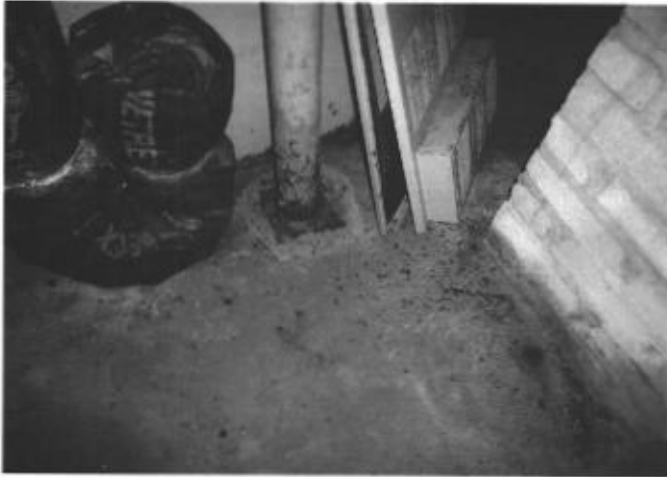
- ☐ Rust was noted at the bottom of the steel support columns. Significant rusting can weaken the structural integrity of the column. Further evaluation recommended.

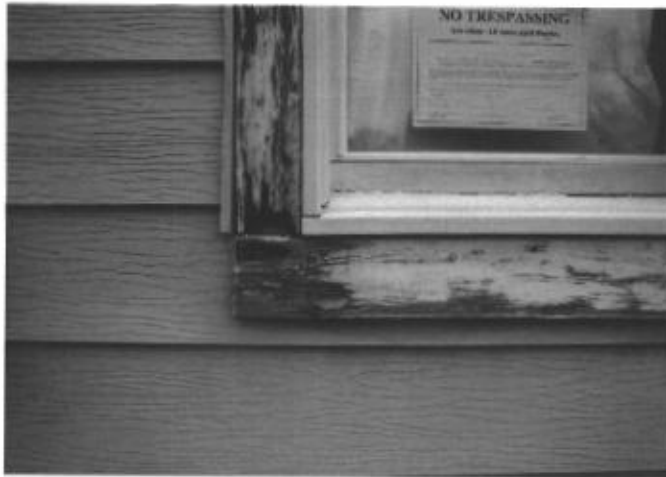
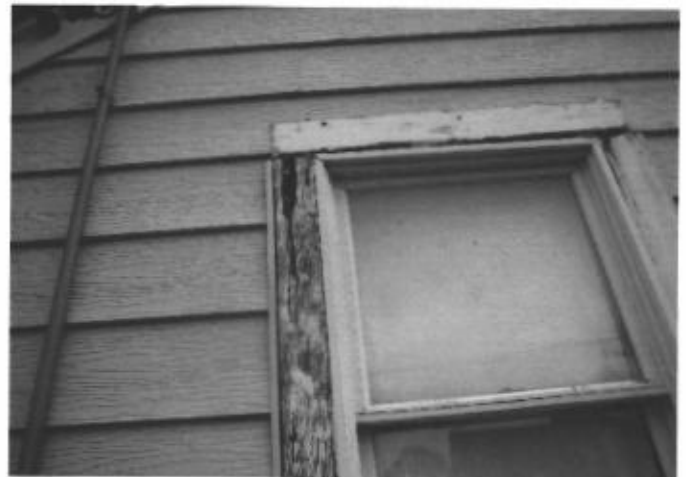
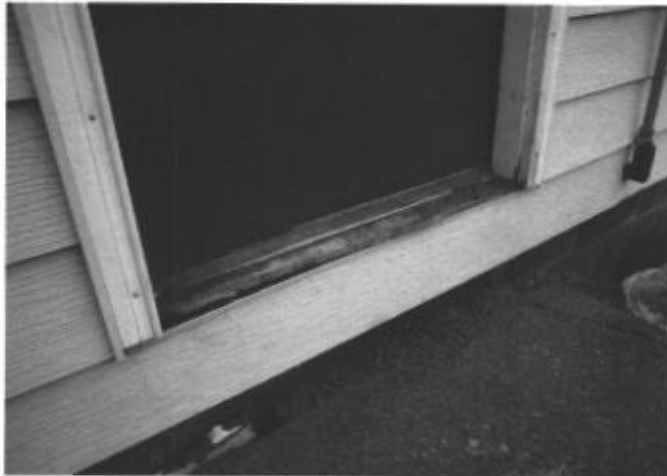
Rotted trim _ - *Continued*

- ☐ The trim is rotted and damaged in some areas. The damaged area may allow entry of moisture and/or insects which could lead to more extensive damage. I recommend that the trim be repaired or replaced.
See Pics

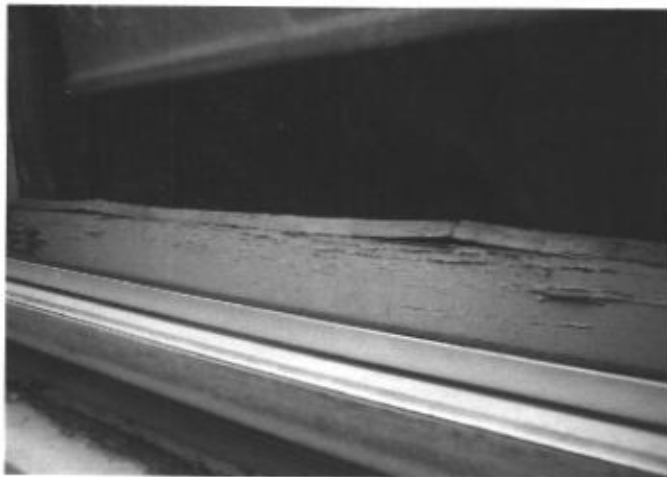
- * The window glazing putty is deteriorated. This glazing putty prevents moisture and air entry between the glass and the window frame.

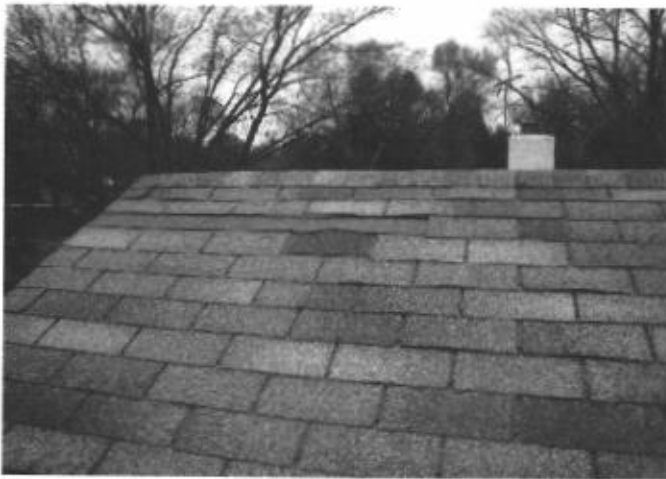
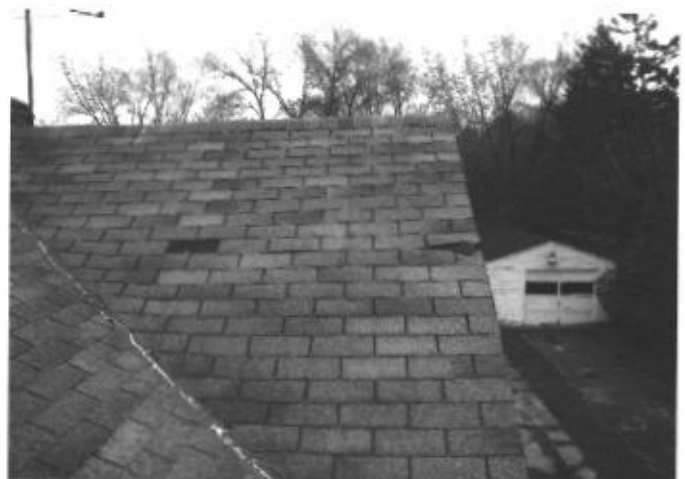
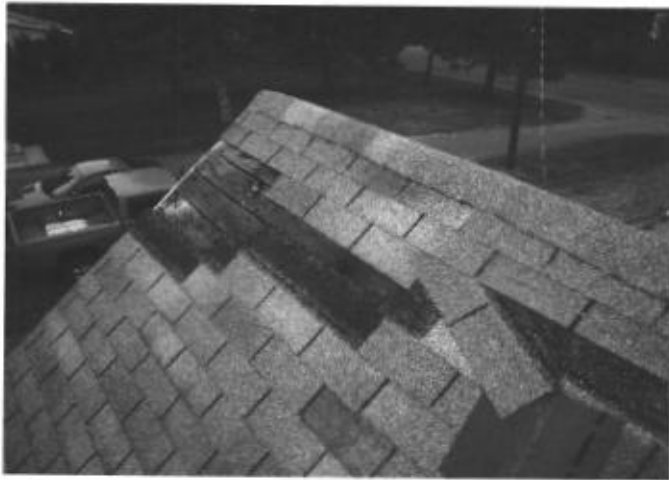
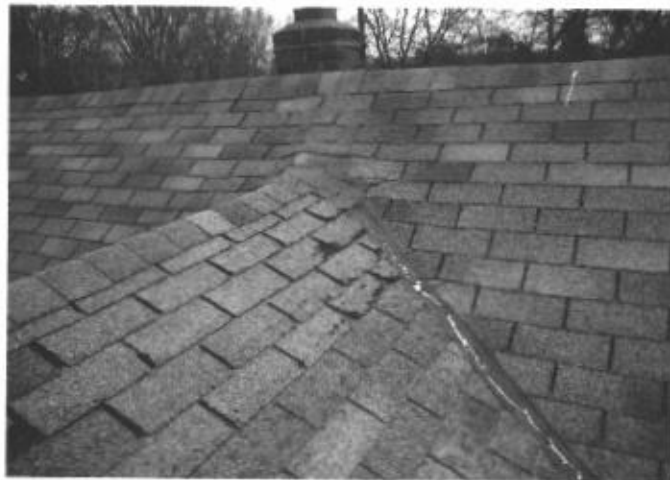
Badly deteriorated asphalt shingles - Continued

- ❖ The roof covering is badly deteriorated. There are broken and missing shingles and underlayment. There are improperly installed shingles and flashing. This condition appears to be allowing water to enter the building, causing interior damage and rot. The roof needs to be replaced.

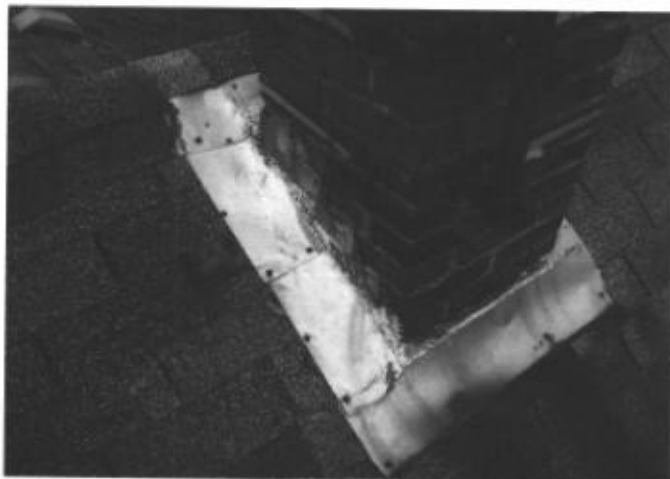
- ☐ The flashings at the chimney are not properly installed. This can allow moisture intrusion into the structure and could cause more extensive damage. Repair or replacement of the flashings is needed.

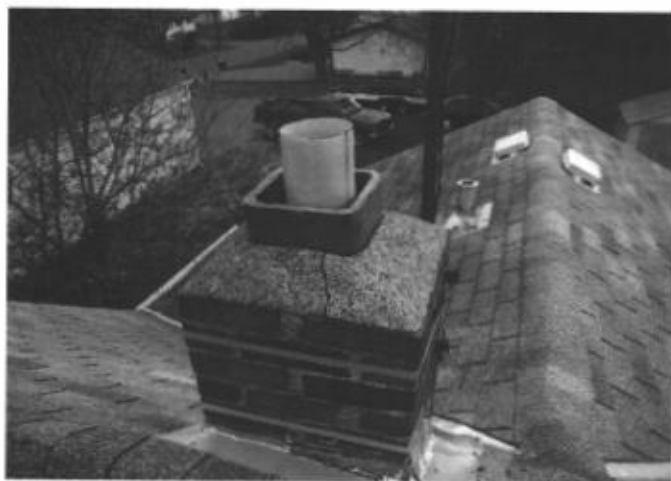
- ☐ The top of each flue of the brick chimney should have a cap and screen. This will help to prevent moisture, animals, and birds from entering the flue and possibly clogging or damaging it.

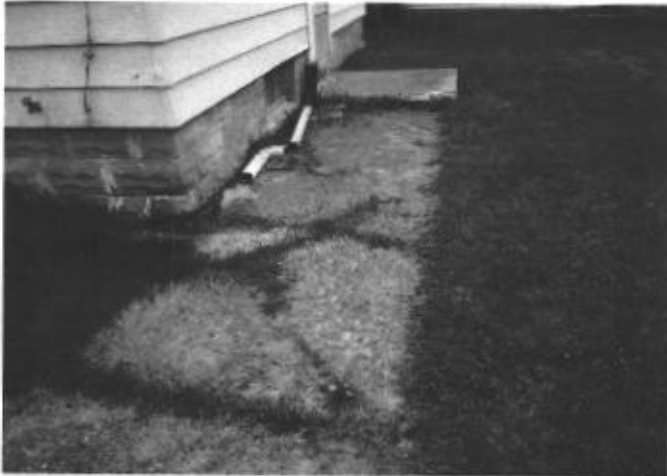
- ☐ A walk and/or patio drains toward the building. This will allow water runoff to accumulate next to the building or penetrate into the below grade spaces of the structure. This may also allow water to pool and cause icing in the winter, creating a slip hazard. Repair or replacement recommended.

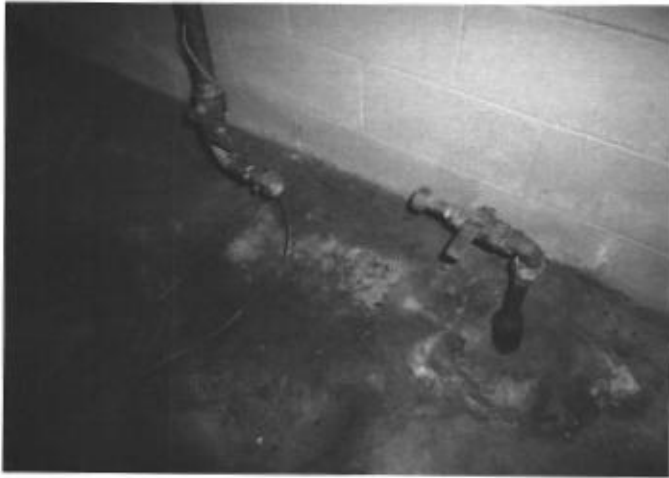
- * The water was turned off to the building at the time of inspection. This limited my ability to test the plumbing system. The information contained in this report reflects only those plumbing components that are readily visible and does not reflect whether any component is functional.

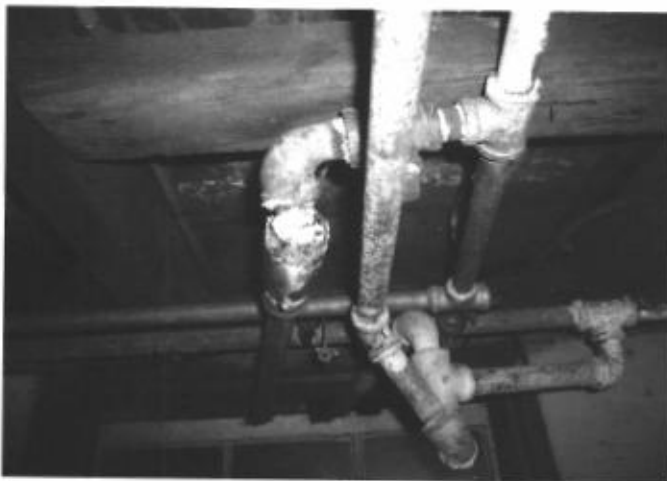
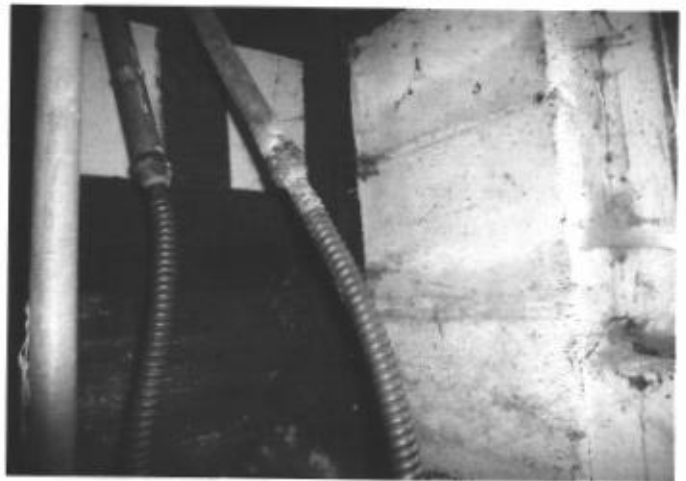
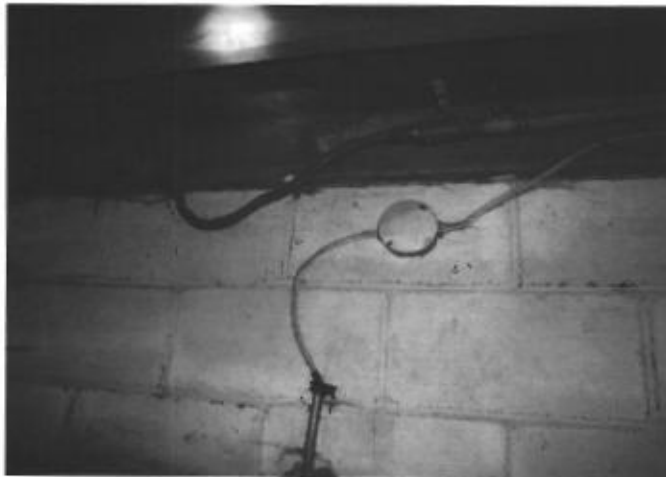
Dissimilar metal corrosion _ - *Continued*

- There is corrosion on the water supply piping and fittings in several locations. There is also evidence of amateur workmanship in the supply system. Improper fittings are used in the supply piping. At least one section of pipe appears to be rusted through or broken. This may result in leakage. Repairs and possible pipe replacement are needed in the plumbing supply system.

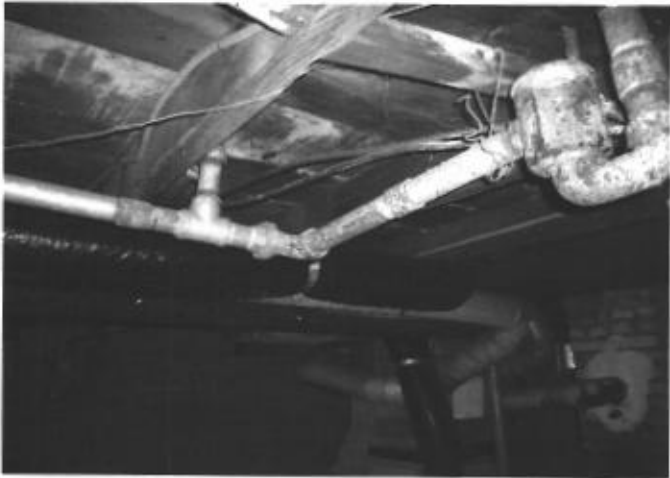
- ☐ The drain pipe that serves the bath tub appears to be improperly pitched. This may cause blockage to occur. Repairs recommended.

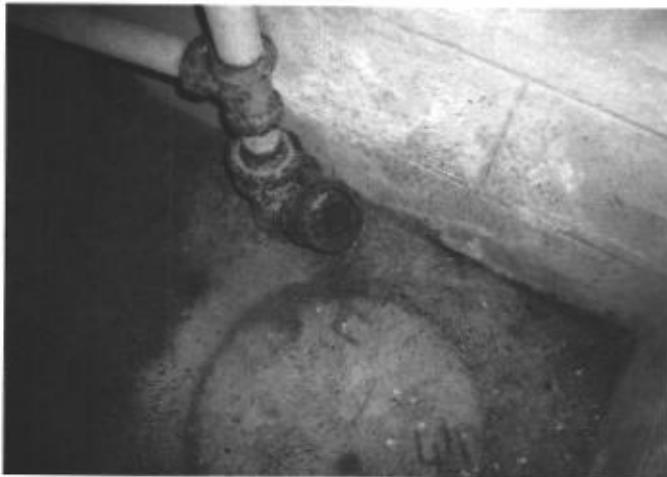
- ☐ There is an open waste line in the basement near the laundry tub. This could allow sewer gases into the building interior. This should be repaired.

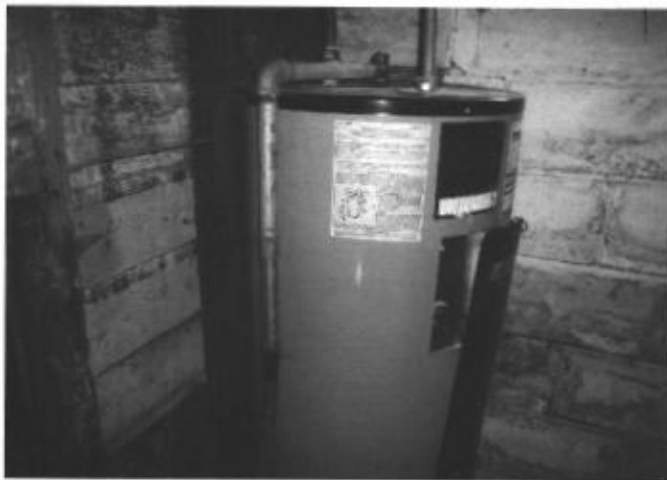
- The water heater is rust and deteriorated, there is an improper TPR extension pipe connection and there appears to be disconnected or missing electrical components. Due to the age and condition of the water heater, it is unlikely that it will function safely. Replacement is recommended.

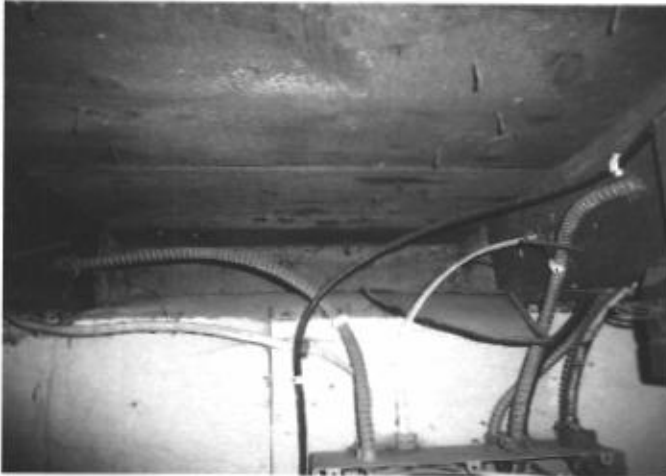
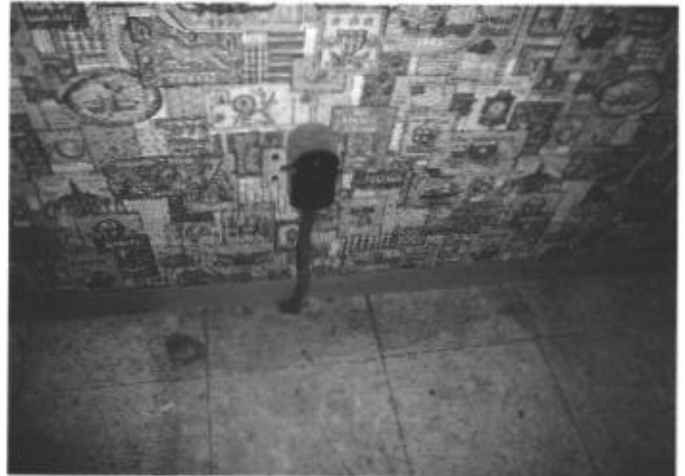
- * Some of the electrical cables are not properly routed, supported or protected. Improperly supported cables can become damaged and may be an indication of amateur workmanship.

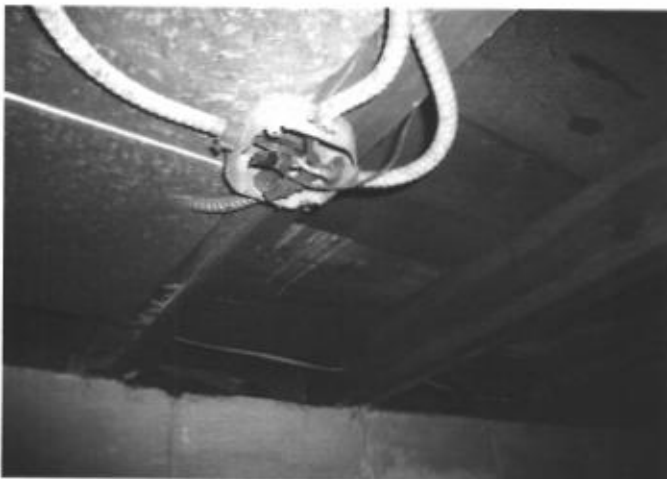
- * Junction box covers or knockouts are missing. Fully enclosed junction boxes are required for fire and mechanical protection. Adding covers is recommended.

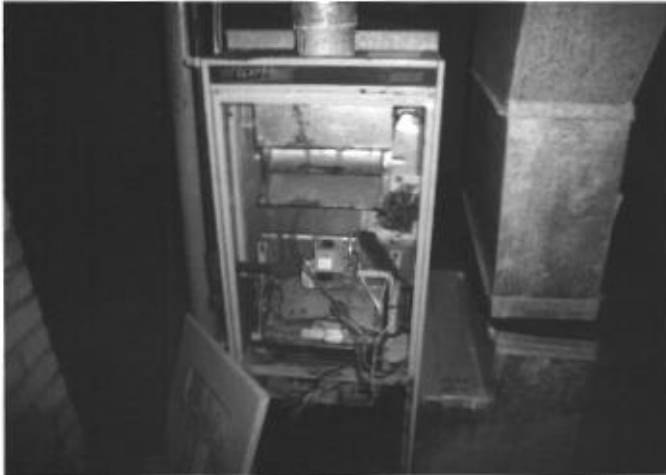
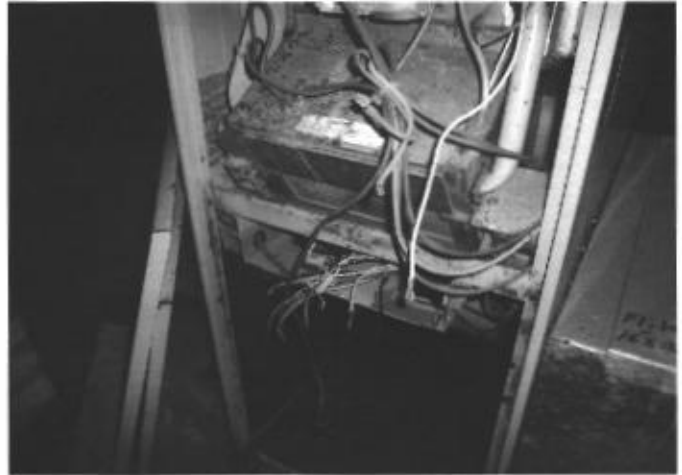
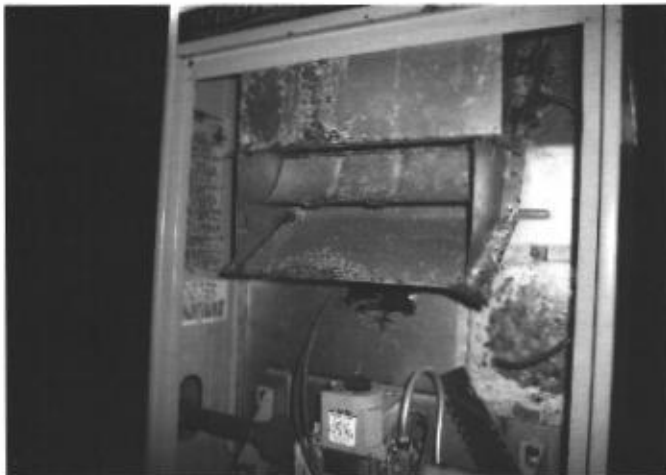
- ❖ There is rust on the furnace and there are missing components and loose electrical wires. Due to the age of the unit and physical condition, it is likely that the furnace can not be made safely operational. Replacement of the furnace is needed.

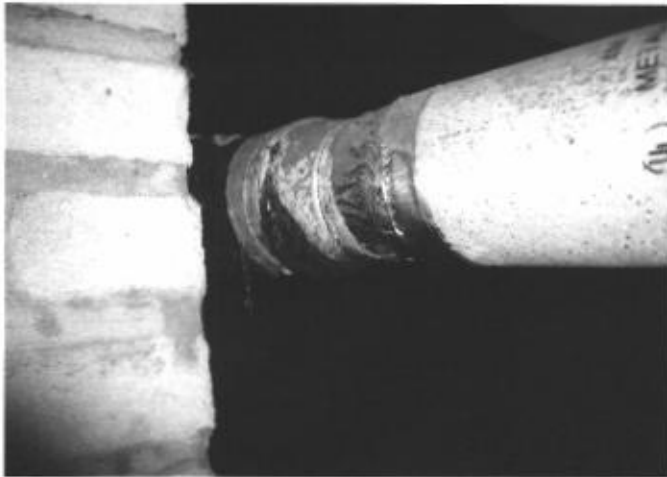
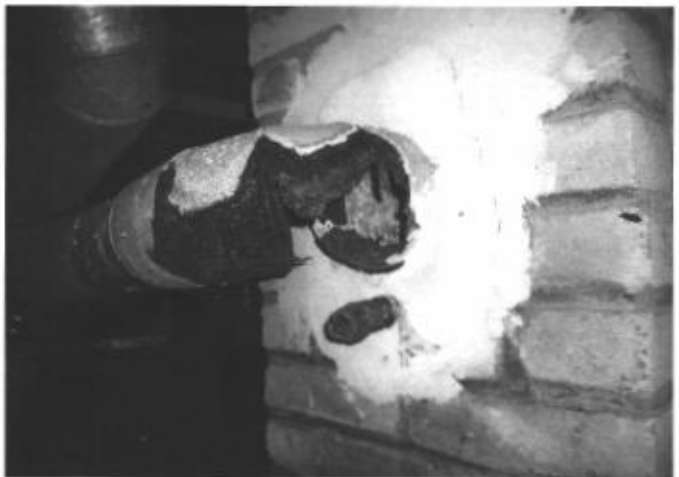
- ❖ The vent piping for the furnace is rusted through. This could allow hazardous exhaust products to enter the building. The pipe should be repaired or replaced.

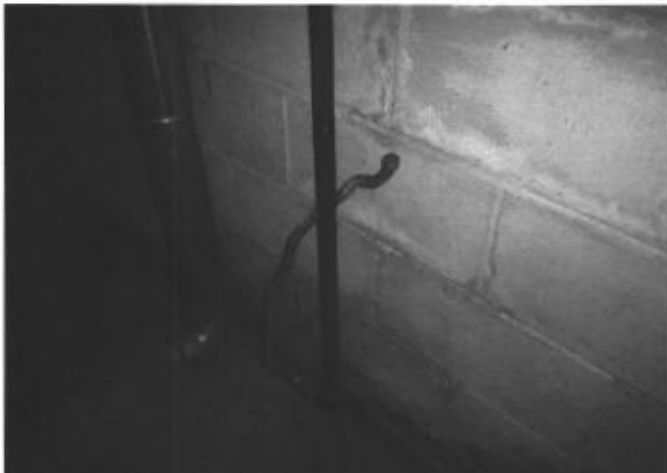
- ❖ There is an uncapped gas line in the utility room in the basement. This line should be capped to prevent future gas leaks.

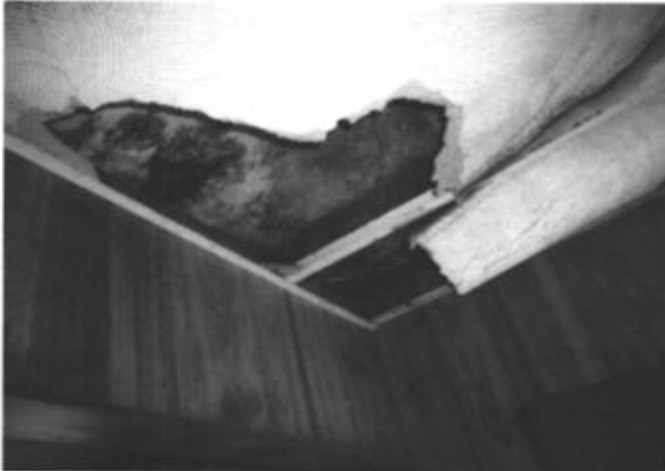
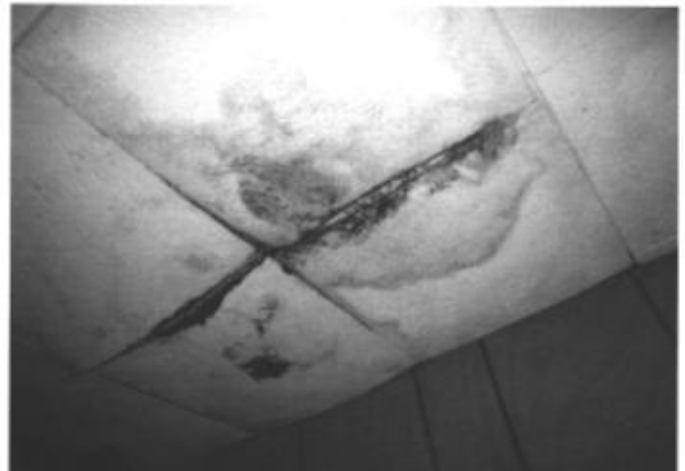
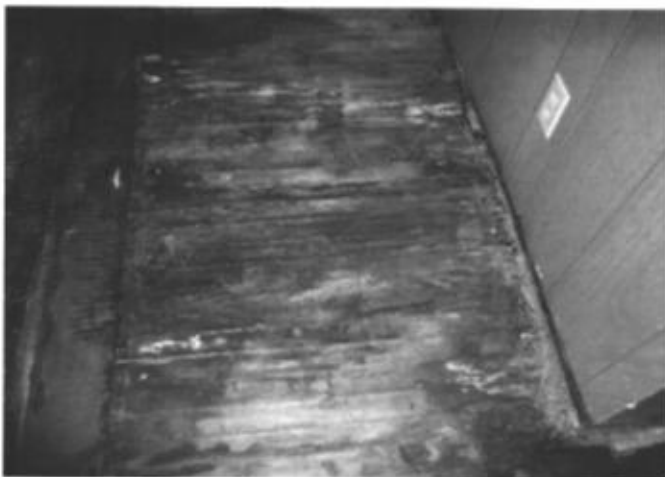
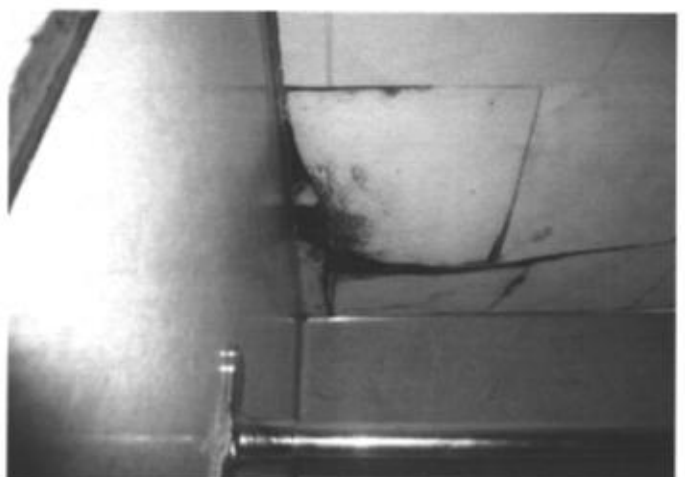
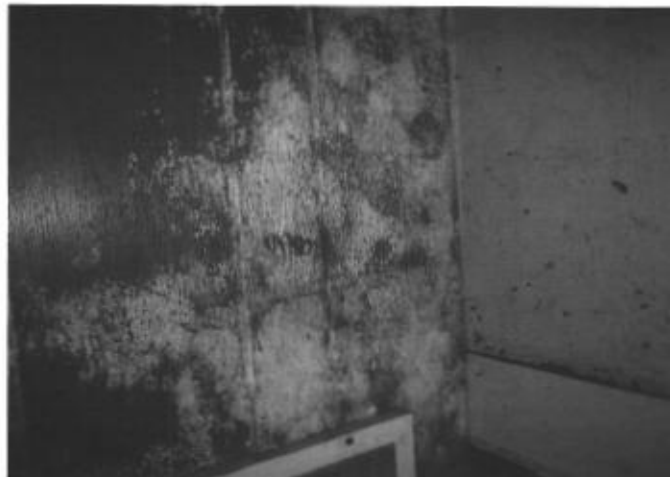
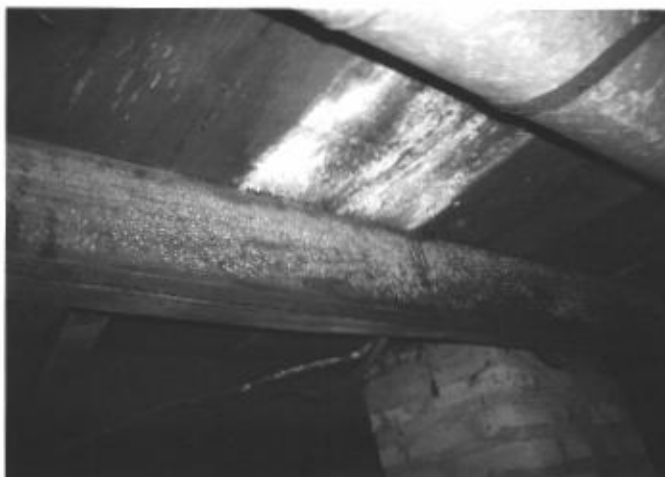
Incomplete Remodel - Continued

- * The interior of the home is in a generally distressed condition. Most or all of the finished surfaces are in poor cosmetic condition and several areas are damaged and will require repairs or replacement to serve their intended function.
- ❖ There is extensive water damage in several areas in the home that appears to be related to water leakage from the exterior and high interior moisture possibly due to improperly vented gas appliances. The damaged areas may also conceal damage to the underlying materials. These areas are likely to require more extensive repairs. There is rot, staining, mold/mildew and evidence of high moisture conditions generally associated with mold or other biological growth. Specific identification of harmful biological growth such as mold is beyond the scope of the inspection. The advice and services of a mold remediation specialist is recommended.

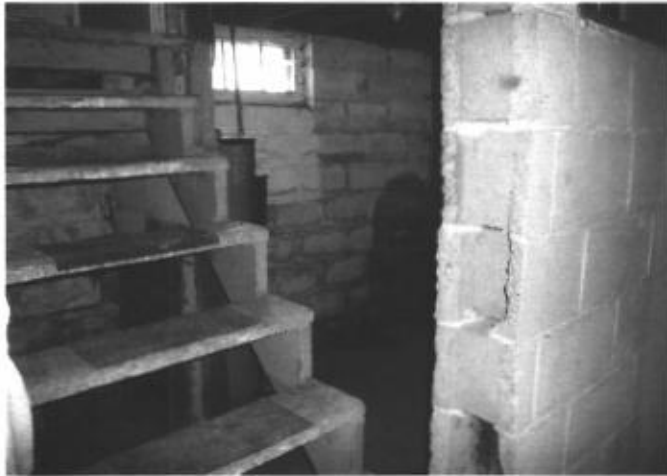
- ☐ There is no handrail at the attic stairway.
- ☐ The sides of the basement stairway are open. There are no hand or guard rails. This is a safety hazard. Installation of hand and guard rails is recommended.

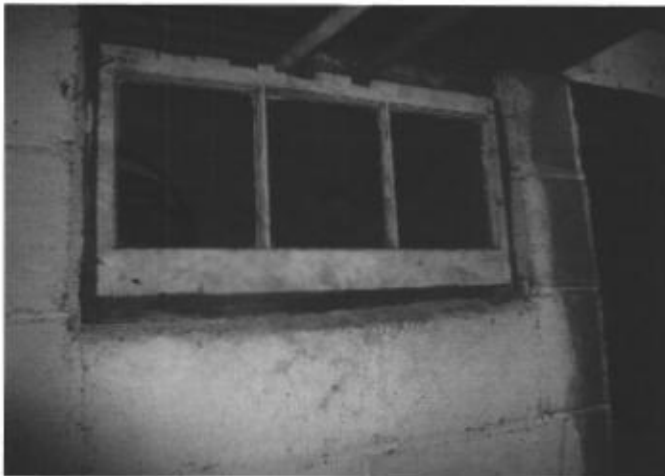
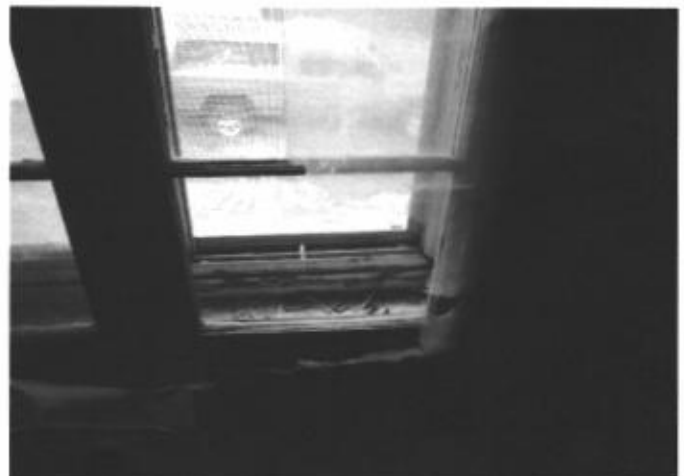
- The window on the south side of attic one basement window have broken panes. This is a safety hazard. Repair or replacement needed.

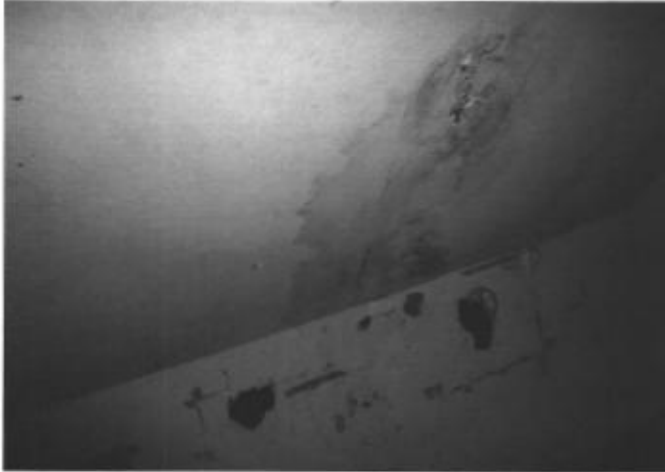
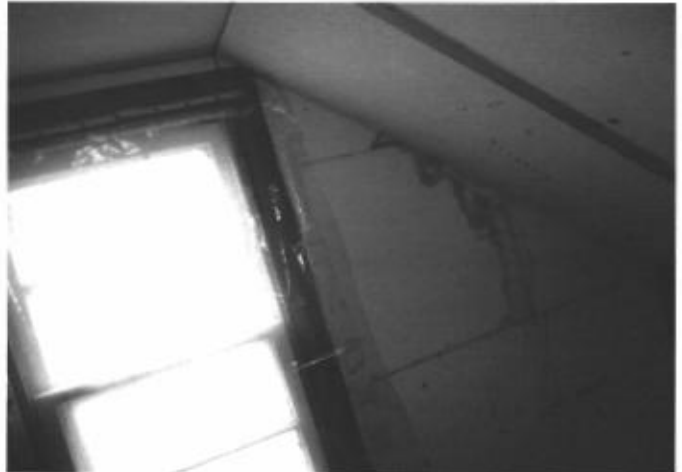
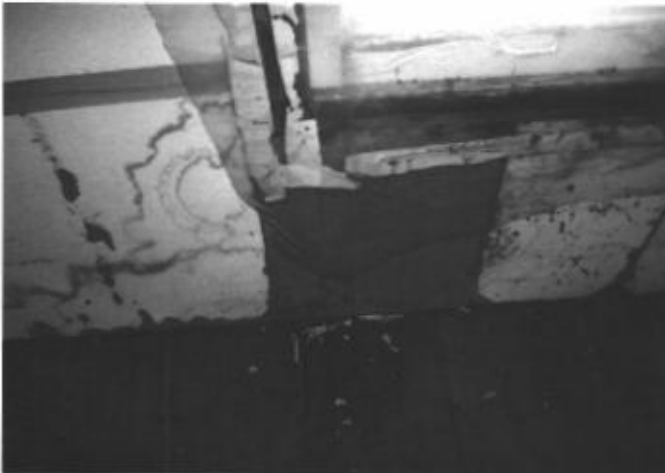
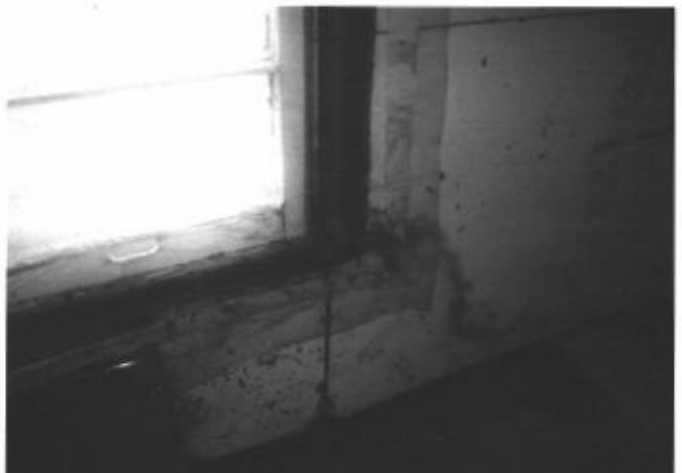
- ☐ There is evidence of active water leakage in the attic. This appears to be from the roof and the North window.

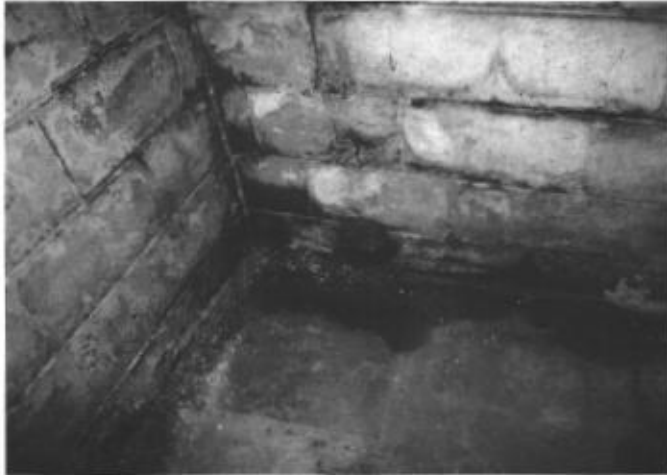
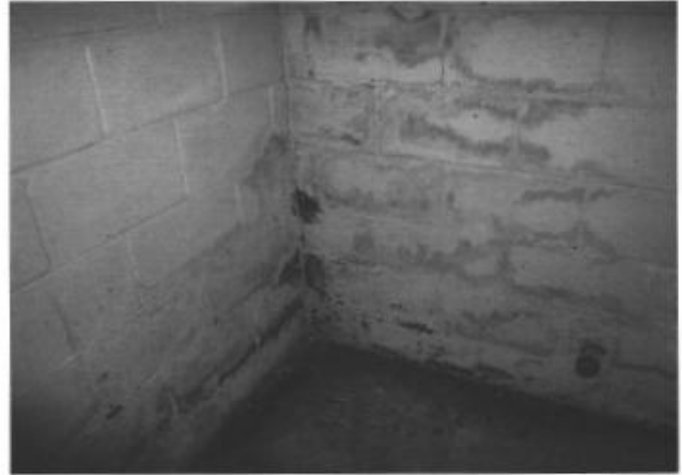
- The following indications of moisture were noted in the basement: efflorescence, swelled or rotted material, peeling paint, stains, biogrowth, odor, damp walls, damp floors. These are indications that there has been water infiltration and it may recur.

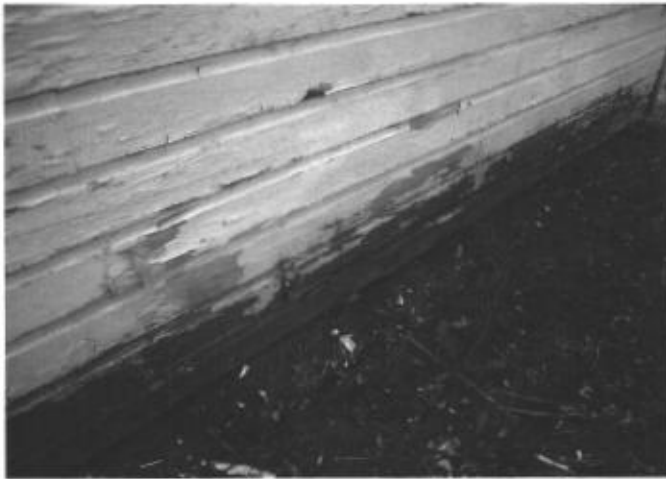
- * The exterior wall surface is wood board siding.
- * There are areas where the siding has minor damage, deterioration.

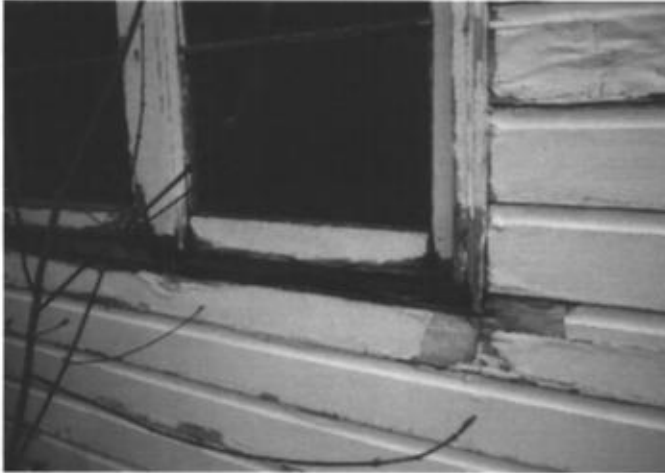
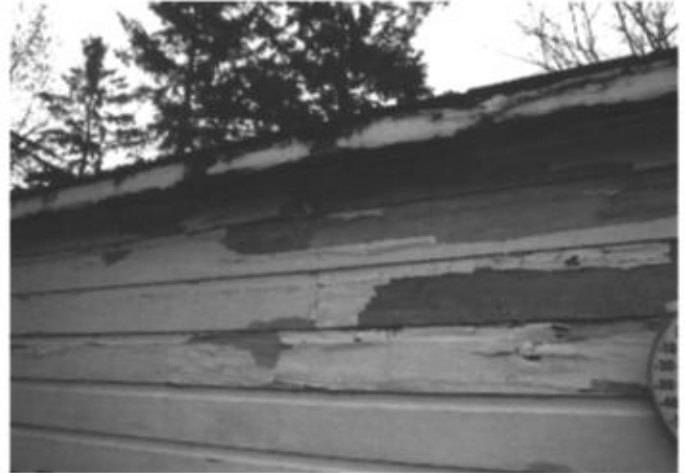
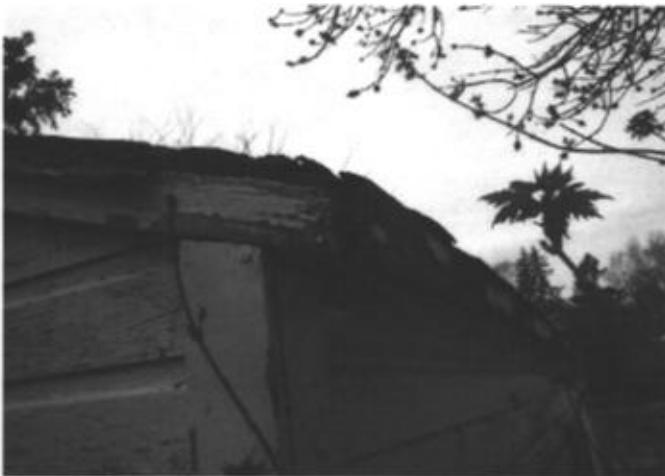
- ☐ The trim is rotted, damaged or missing in some areas on the garage. The damaged area may allow entry of moisture and/or insects which could lead to more extensive damage. This trim should be repaired or replaced.

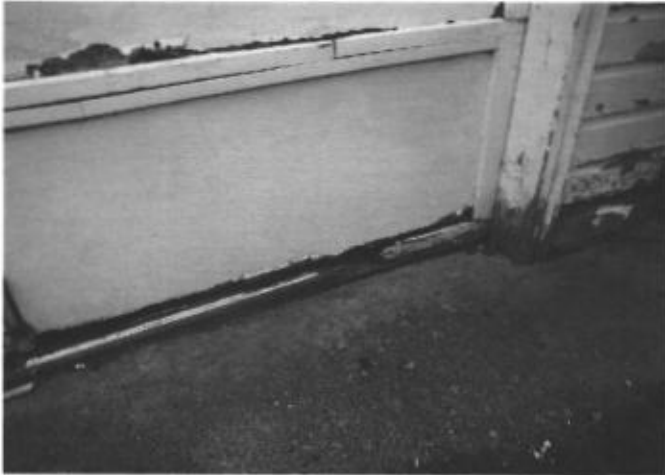
- ☐ The garage door is deteriorated. The door may not be able to support its own weight when open. Repair or replacement of the door is needed for use of the garage.

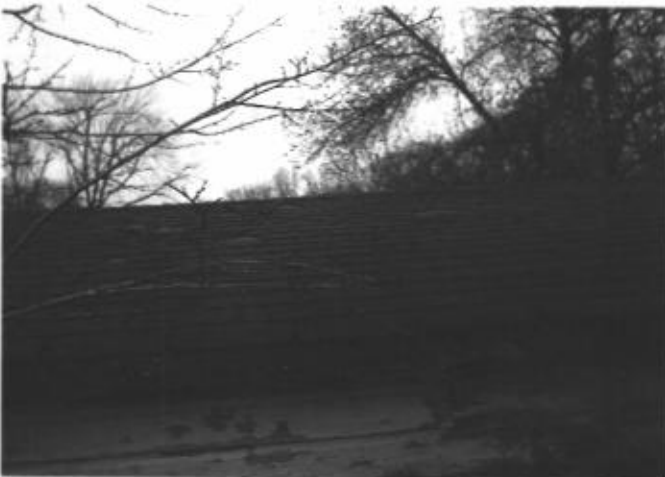
- ☐ The materials and age of the roof covering on the garage or out building are similar in age and composition and condition to the main structure. Leaks are likely. Due to age and condition, replacement of the garage roof is needed.
