HAZARDOUS MATERIALS SURVEY

1057-1059 Dayton Avenue
Saint Paul, Minnesota

Prepared For:
Ramsey County Tax Forfeited Lands

May 1, 2014

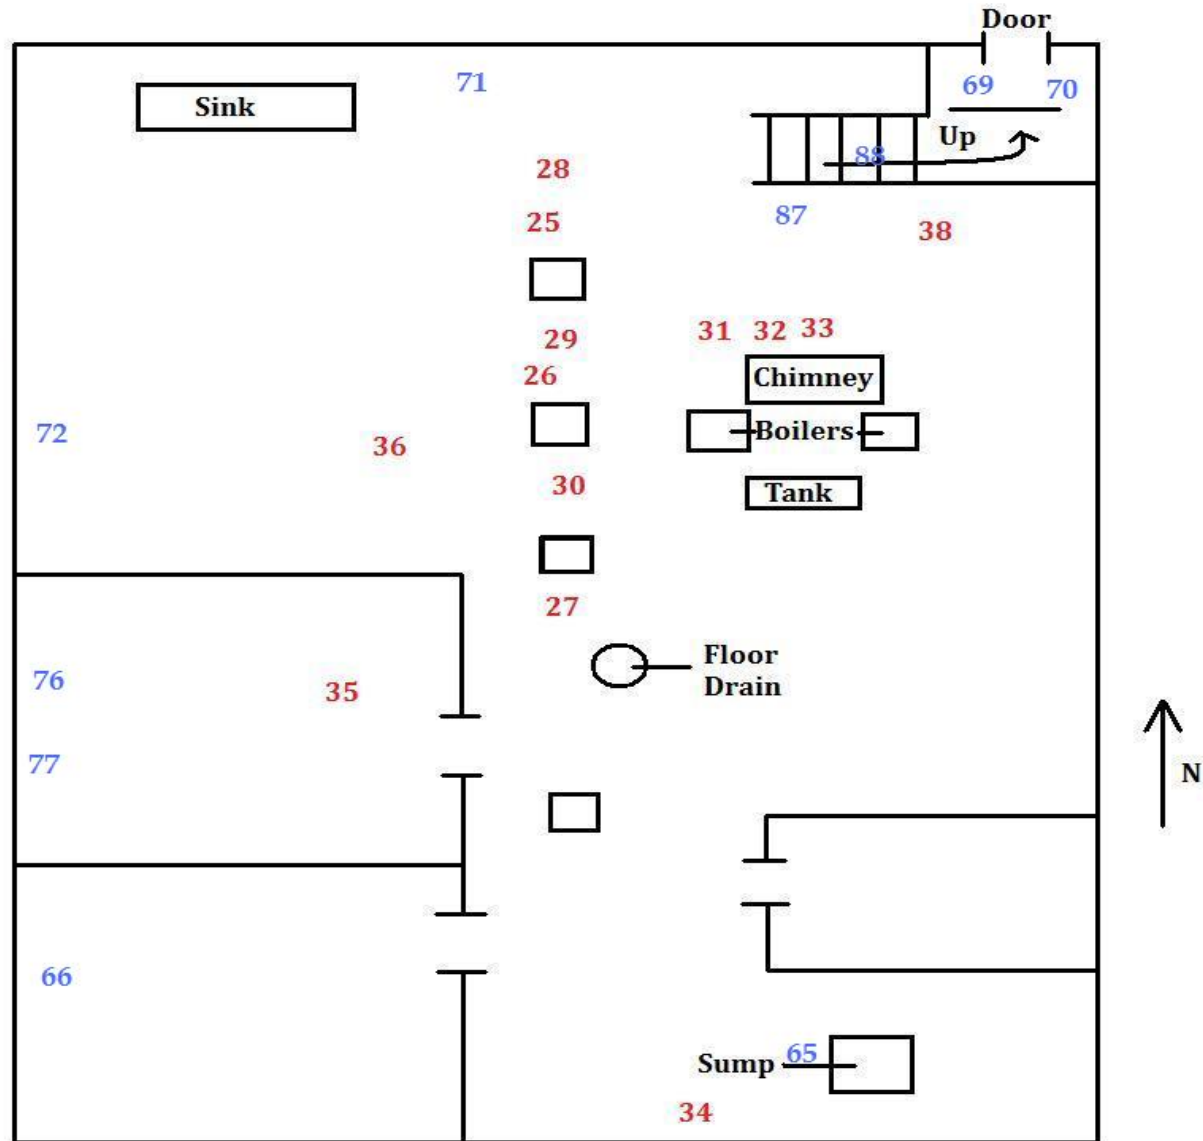
Basement (Apt. # 1057-1059)

- Asbestos Samples
- Lead Positive Readings

Appendix A – Laboratory Analytical Results
Appendix B – Sample Location Diagrams
Appendix C – Summary of Qualifications

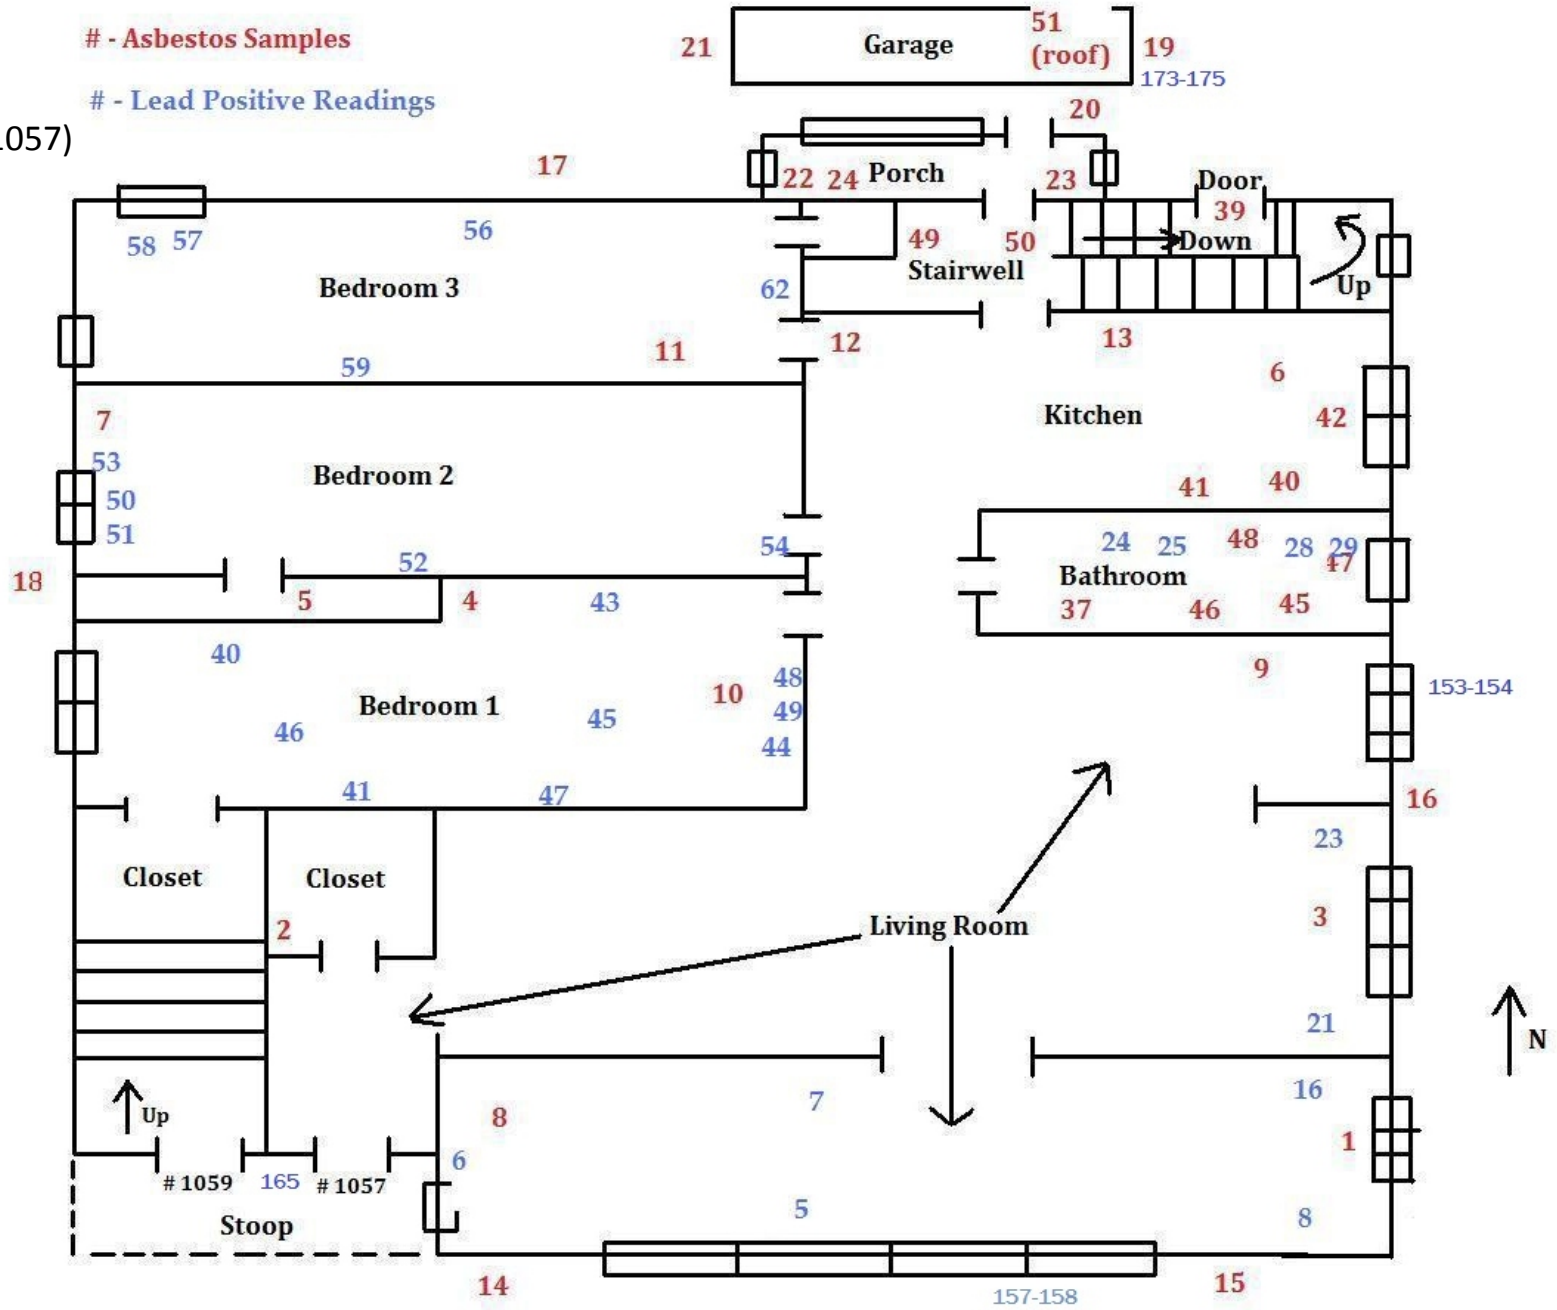
- Asbestos Samples

- Lead Positive Readings
